# The Bowmont catchment initiative: **An assessment of catchment hydrology and Natural Flood Management measures**

Four year summary

**Stephen Addy & Mark Wilkinson** February 2017

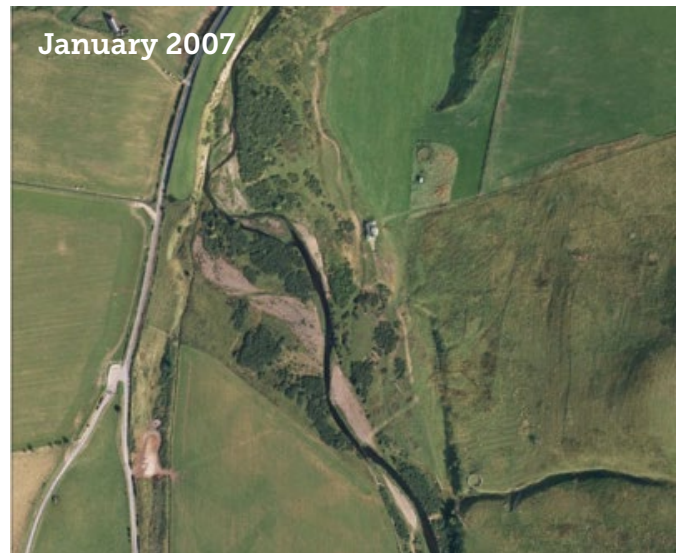
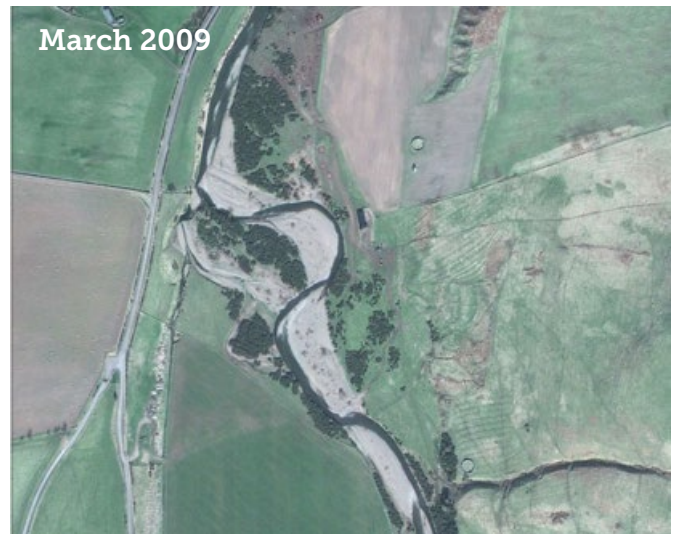
Figure 2: In response to the September 2008 flood, parts of the Bowmont Water experienced marked gravel deposition and changes in channel planform. Images show the Bowmont Water downstream of Attonburn (Imagery from Google Earth).

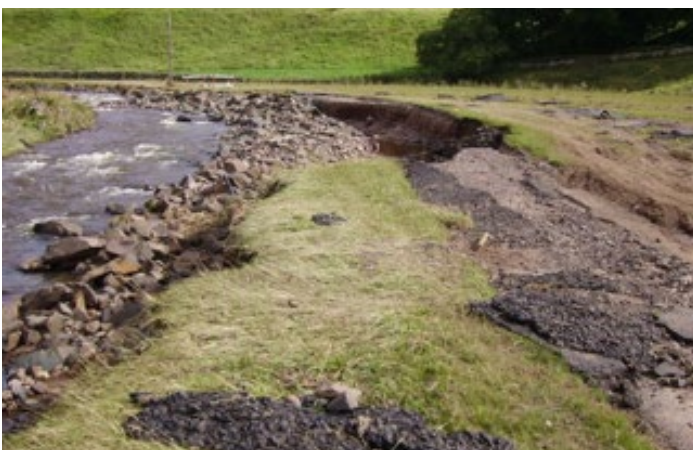
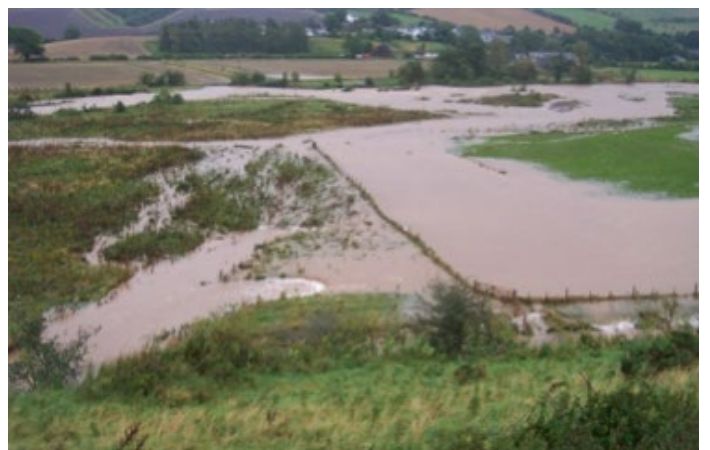
Figure 1: (Left) Damaged road near Mowhaugh in the Bowmont valley after the July 2009 flood (© Gordon Common) and (Right) inundation of the floodplain at Venchen downstream of Town Yetholm during the 25th of September 2012 flood event (© Hugh Chalmers, Tweed Forum).

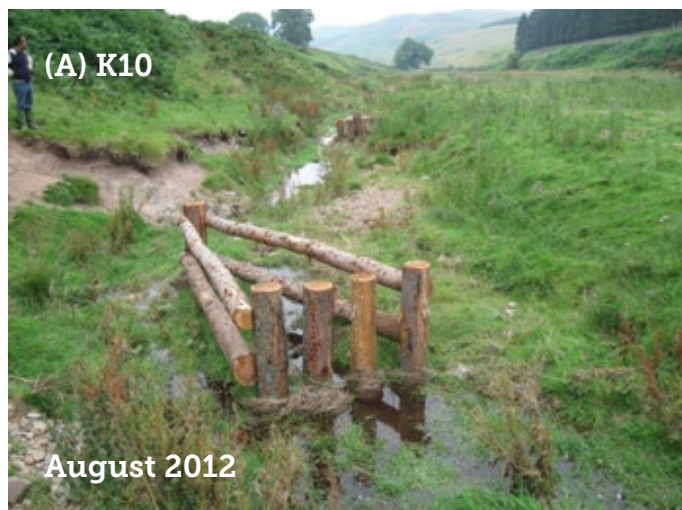
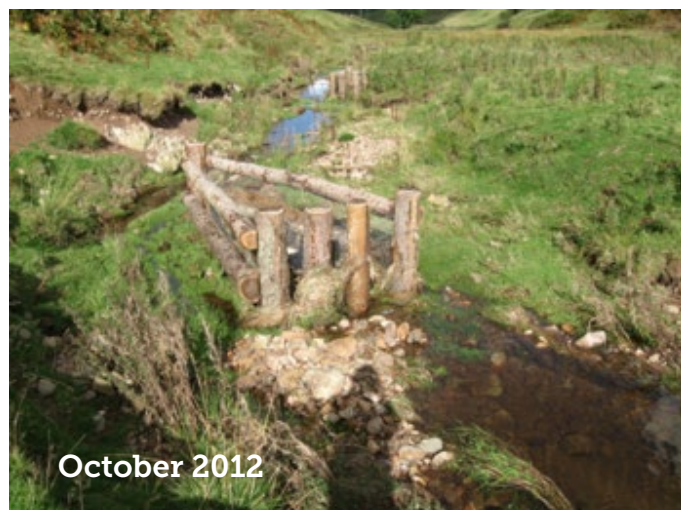
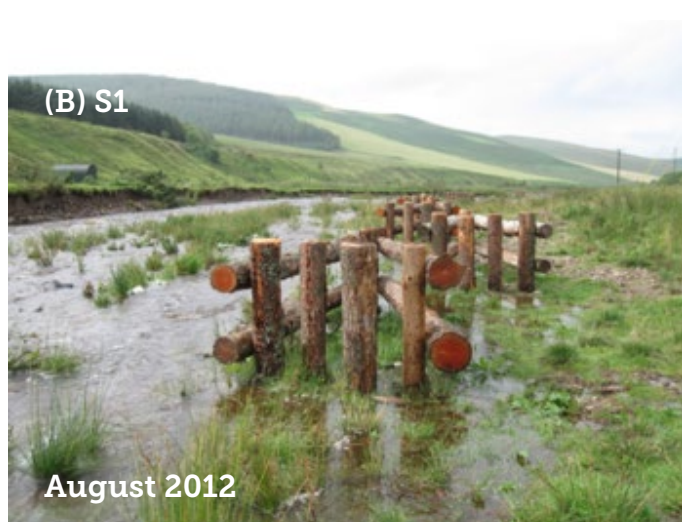
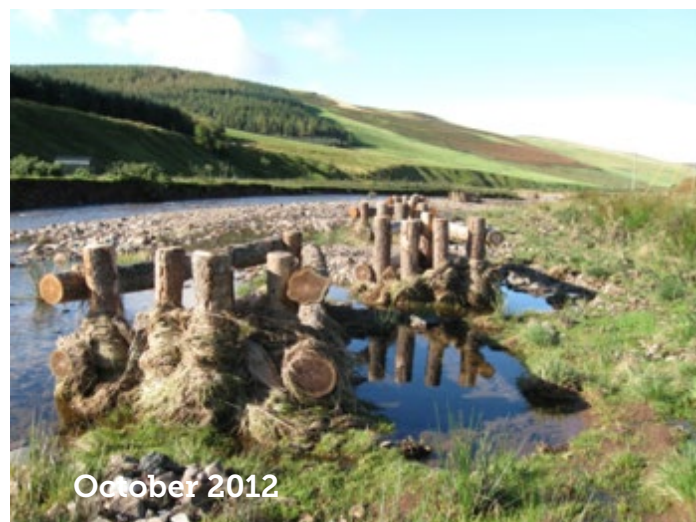
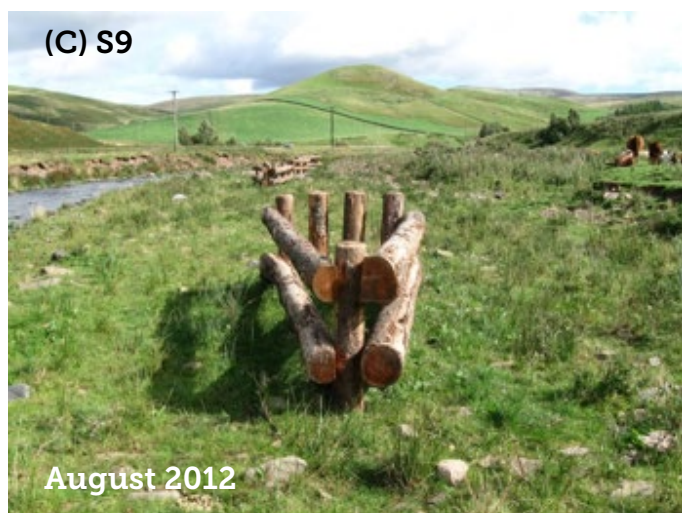
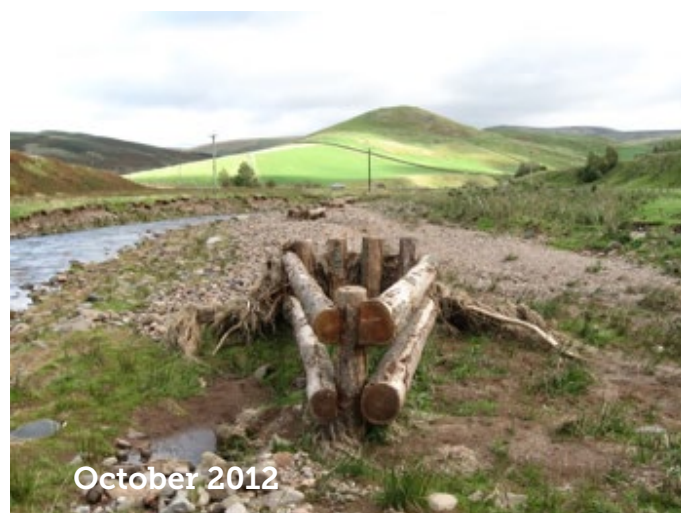
Figure 20: Selected examples of different responses at BAELJs (see Figure 19 for locations of structures). (A) deposition on the upstream side of a Kelsocleuch structure, (B) capture of debris and formation of scour pools at Bar 1, Swindon Haugh, (C) capture of debris and deposition of a gravel sheet upstream of a structure at Bar 2, Swindon Haugh (see Figure 19 for locations). Figure 20 continues overleaf.

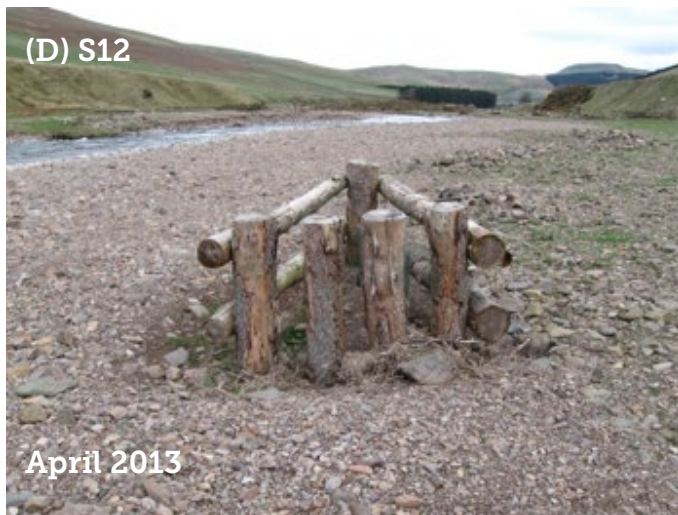
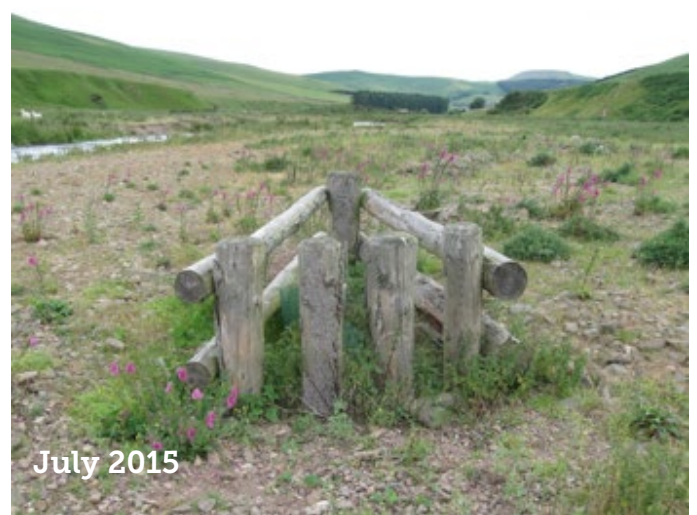
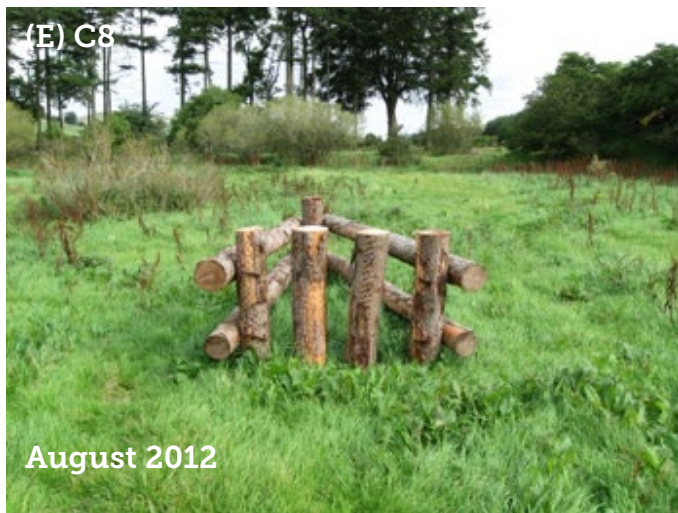
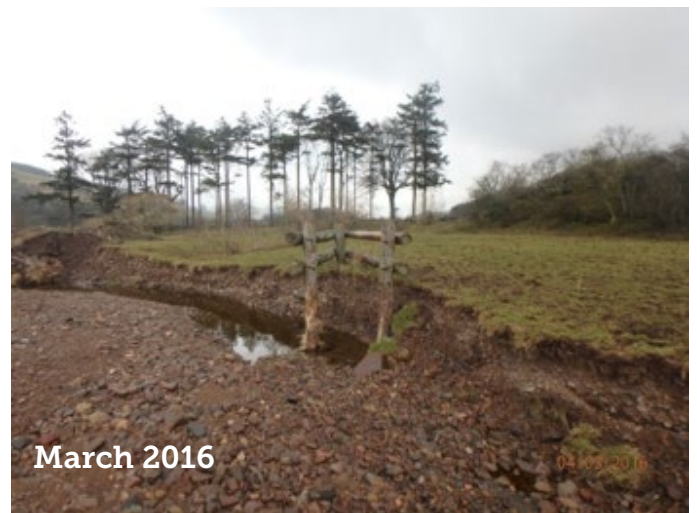
Figure 20 continued. (D) stabilisation of gravel deposited by the September 2012 flood event through vegetation colonisation and (E) erosion of floodplain and material surrounding the piles of a structure at Clifton caused by natural channel movement. Note the removal of two of the pile anchors presumably by the December 2015 or January 2016 floods (see Figure 19 for locations).

- Between August 2012 and March 2016, 5 out of 45 structures have been lost and 5 of the 40 structures that have remained in place have been damaged (Figure 21(A) e.g. Figure 20(E).

- The survival reflects the structure stability offered by the pile anchors and placement in low energy settings (floodplain and bar depositional zones) rather than high energy settings (e.g. mid-channel locations). However, the complete washout of some structures or damage to timbers show they are vulnerable if placed in sensitive locations (e.g. close to the outer sides of meander bends where bank erosion tends to be concentrated; Figure 20(E)).

- Log jams should be placed in areas of sediment transport (wetted channel and active gravel bar areas). Log jams placed in stable areas of floodplain are ineffective by being outside the zone of sediment transport and are unlikely to have an appreciable effect on flow attenuation. They are also vulnerable to damage or displacement through the erosion of material into which pile anchors are driven.

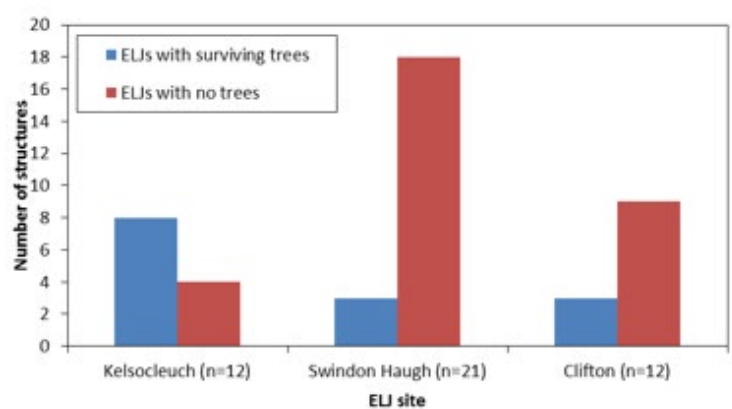
- Trees planted in Spring 2013 have in most places not survived (31 out of 45) presumably reflecting grazing pressures or displacement by floods (Figure 21(B)). Survival may have also been influenced by the soil conditions; trees planted on gravel bars have in particular not fared well perhaps due to the poor growing conditions of the freely draining alluvium.

Figure 21(A): Bar apex ELJ structure state of repair as of March 2016. (B): Status of trees planted in Spring 2013 and assessed in March 2016.

- Trees planted within structures need to be better protected to ensure they can survive grazing and flooding. Consideration should also be given to the soil conditions.

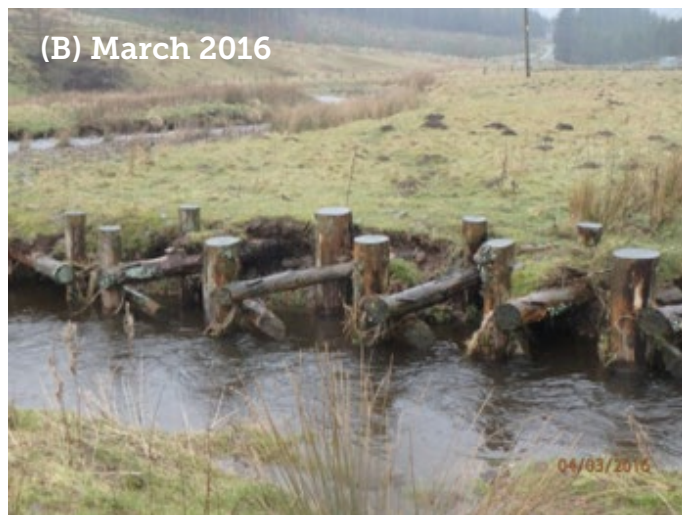
**(B) March 2016**

Figure 27: Downstream section of Structure 1 between August 2012 and March 2016. Note the erosion of placed gravel backfill and turf followed by progressive erosion of the bank.

- The structures have remained intact over time and show no signs of displacement (Figure 27). The backfill has been removed in places especially at Structure 1.
- Vegetation has encroached on to the bar surfaces indicating favourable growing conditions probably aided by the paucity of high flows that can disrupt plant colonisation during the monitoring period (Figure 28). This matches observations from other sites and is unlikely to be related to the presence of the structures.
- A large number of small fish (parr and fry?) were observed using the reach especially in the pool in between the two structures. It is not clear if structures have improved cover for the fish making the reach more attractive or if the pool - which reflects natural processes rather than the effect of the structures – offers particularly attractive habitat.

- Consideration should be given to the strength of any backfill and turfs used to provide further bank reinforcement after structure installation; loose backfill doesn't stay in place in all settings and continued grazing prevents the development of natural vegetation that increases resistance.

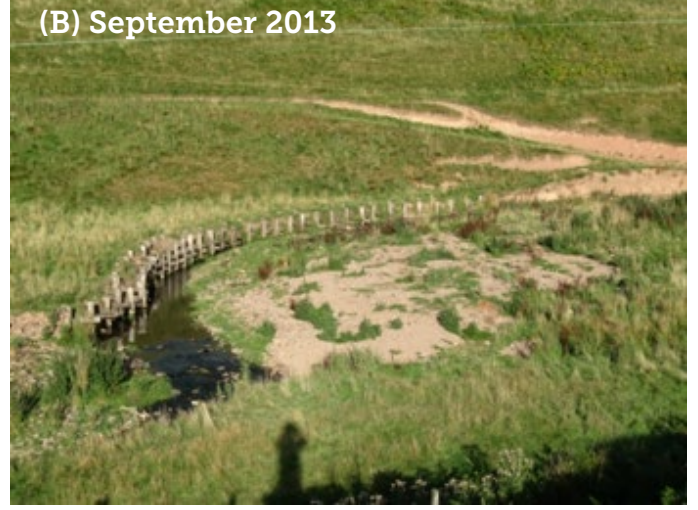
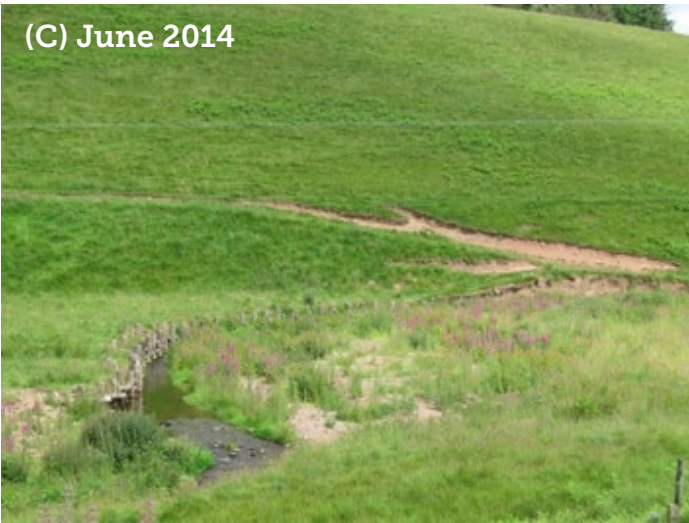
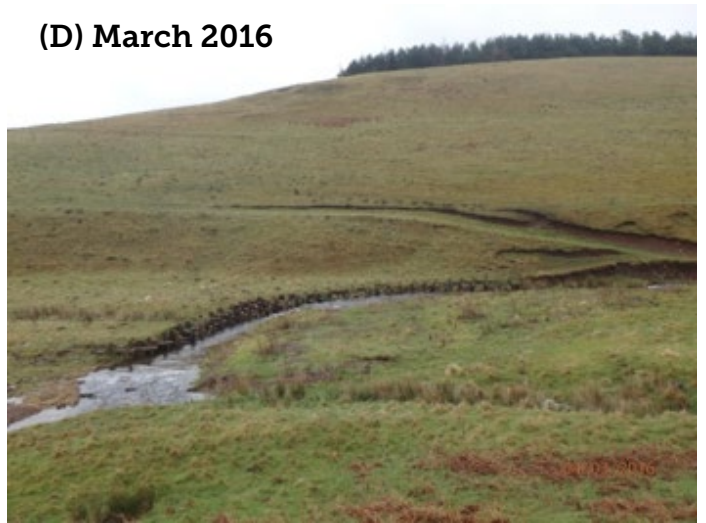
**Figure 28: Changes to the channel and point gravel bar adjacent to Structure 1 between October 2012 and March 2016. Note narrowing of the wetted channel and the encroachment of vegetation over the stabilising bar.**

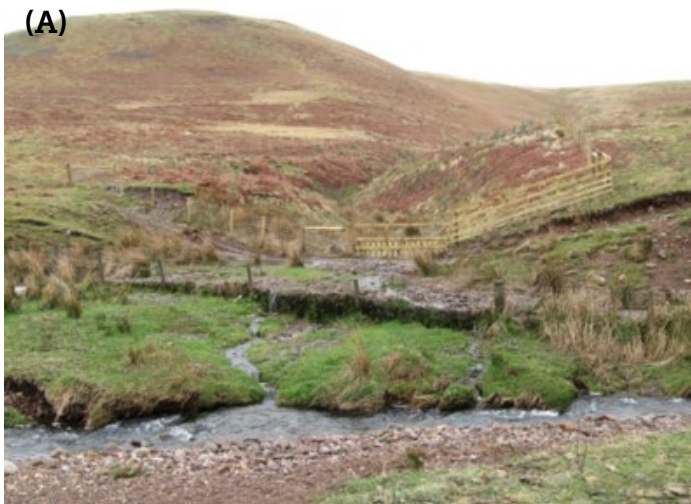
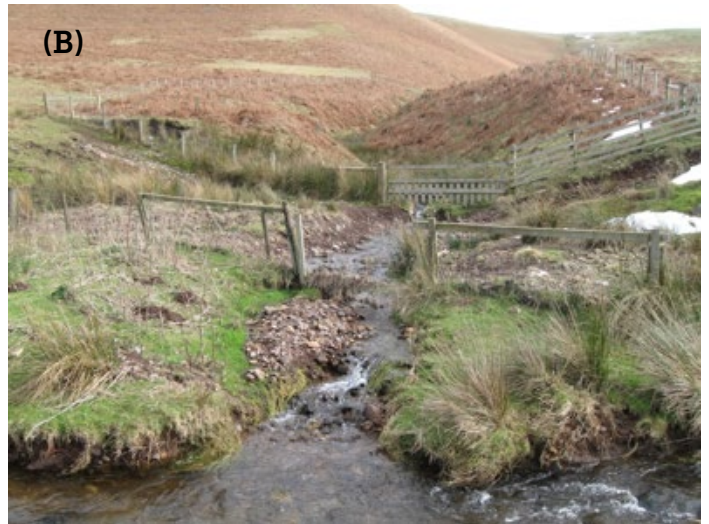
Figure 33: (A) Outlet of the Elm Sike in April 2013 before the flow restrictors were installed but with the fenced enclosure established. Note the large build up of coarse sediment in an alluvial fan between the fences. (B) The approximate same view in February 2016 after dredging of the channel in Autumn 2013 and following several flows sufficient to move coarse sediment and re-shape the channel (including 5th and 27th of January 2016 floods).

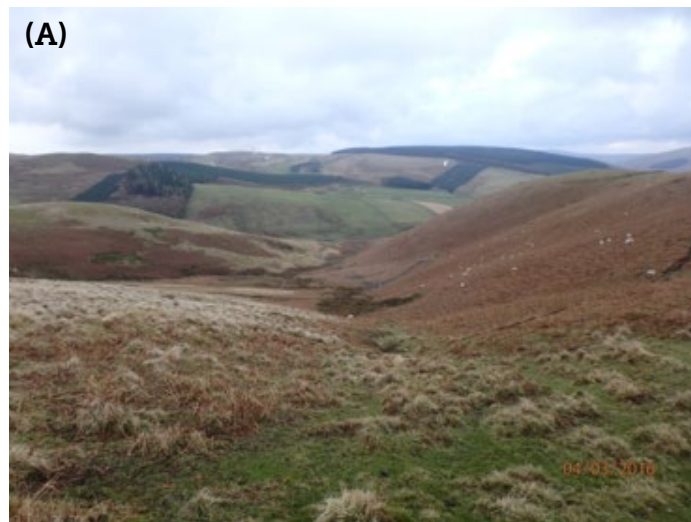
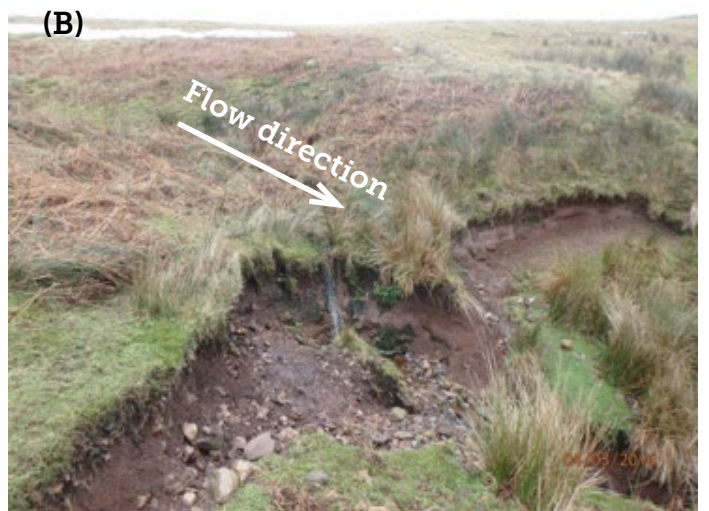
Figure 34: (A) View of the Elm Sike catchment taken from Cock Law in March 2016. (B) A channel headcut on the upper Elm Sike in March 2016. Note the sudden difference in channel width and depth at the small waterfall created by scour.

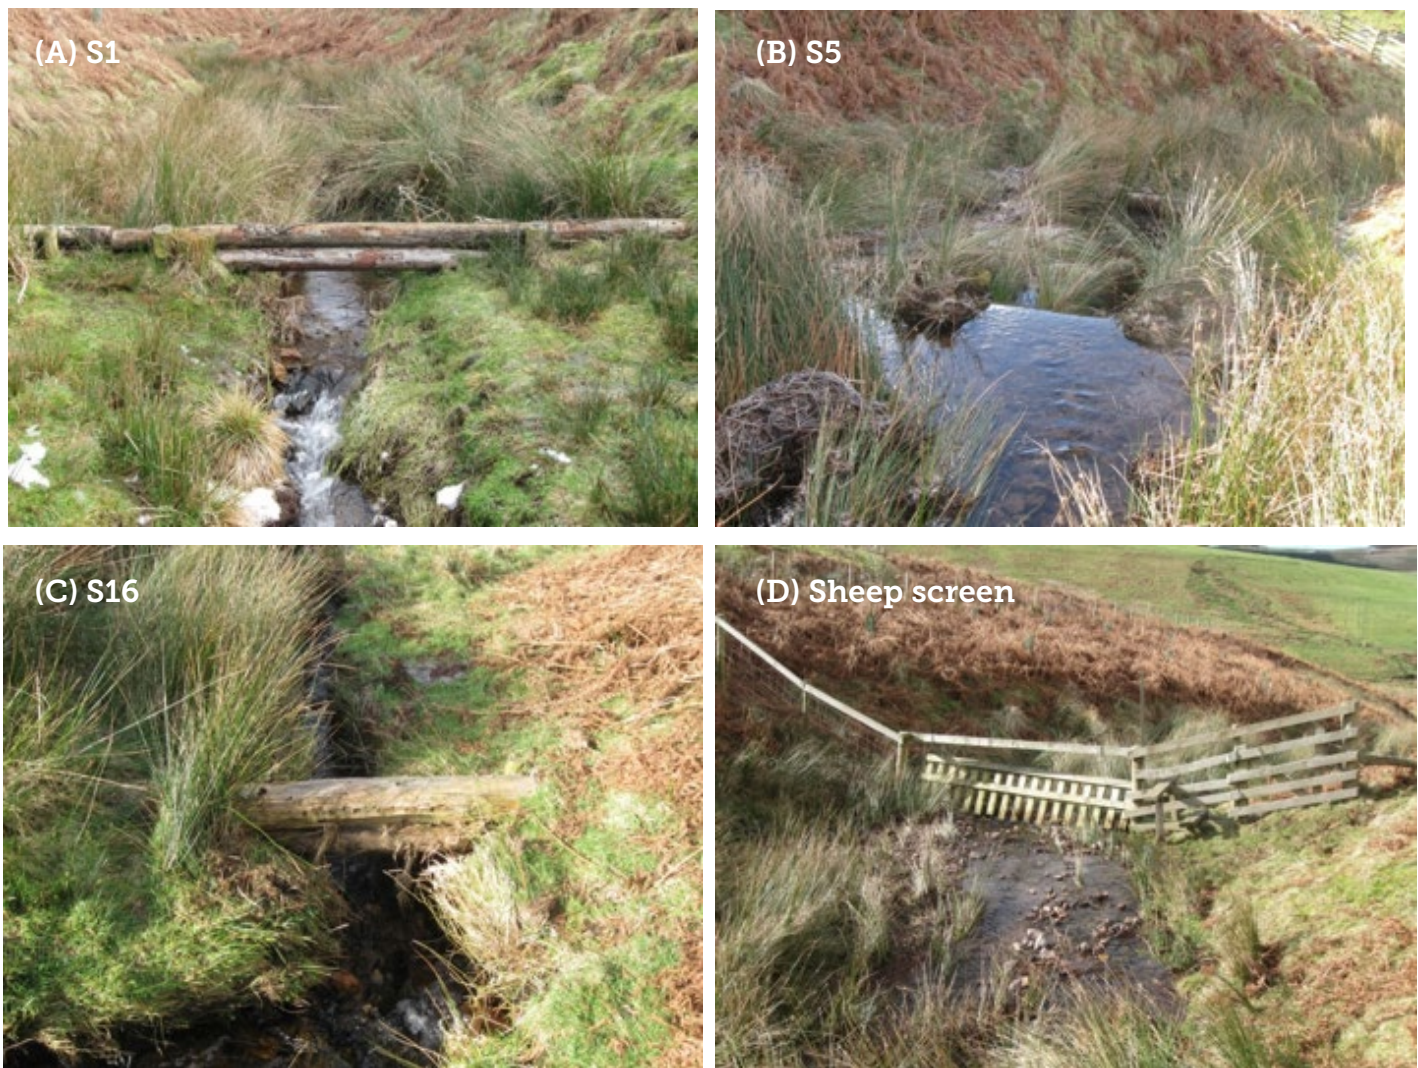
**Figure 40:** Selected range of geomorphic responses observed during the February 2016 survey (following several high flows in December 2015 and January 2016). Refer to Figure 38 for the locations of these sites. (A) Vertical scour of up to 0.35 m below a flow restrictor. (B) Deposition of 0.85 m<sup>3</sup> of material upstream of a flow restrictor (C) Scour of up to 0.1 m underneath a flow restrictor and trapping of debris. (D) Deposition of 2.9 m<sup>3</sup> of sediment upstream of the sheep screen at the upper end of the fenced enclosure.
