Effect of Soil Structure and Field Drainage on Water Quality and Flood Risk

Hallett, P., Hall, R., Lilly, A., Baggaley, B., Crooks, B., Ball, B., Raffan, A., Braun, H., Russell, T., Aitkenhead, M., Riach, D., Rowan, J., Long, A. (2016). Effect of soil structure and field drainage on water quality and flood risk. CRW2014_03

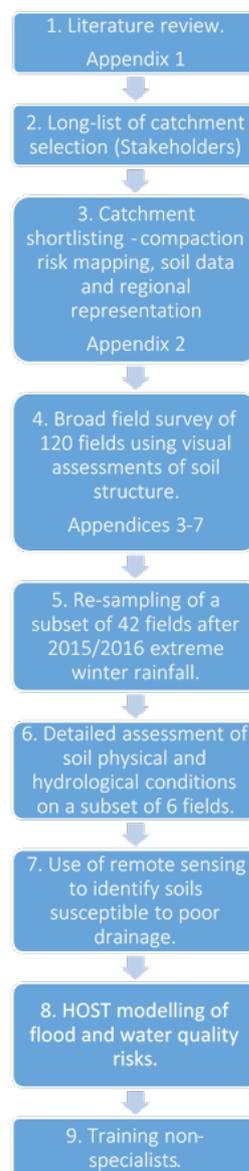
Figure 1 – Research pathway to assess soil structure and drainage conditions and impacts for Scotland. Details of some steps can be found in the Appendices, as indicated above.

We followed the pathway in Figure 1 to collect and interpret data on the extent and impact of soil structure and drainage degradation in Scotland. First we reviewed past literature to collate information on soil structure and drainage from previous work in Scotland and elsewhere. The review also verified our sampling approaches. We then identified sampling locations, with the intention of covering 120 fields across 4 catchments. A steering group provided a long-list of catchments to represent areas of concern for soil structure and drainage. Using soil mapping and modelling, we identified four catchments (and several reserve catchments) that provided geographic spread, a range of soil types and different vulnerabilities to soil compaction. Sampling locations were divided between catchments with about 30 each (27 in the Coyle, 32 in the East Pow, 30 in the south Esk and 31 in the Ugie Catchments.), with farmers contacted to access fields and start questionnaires on their cropping practices and drainage systems.

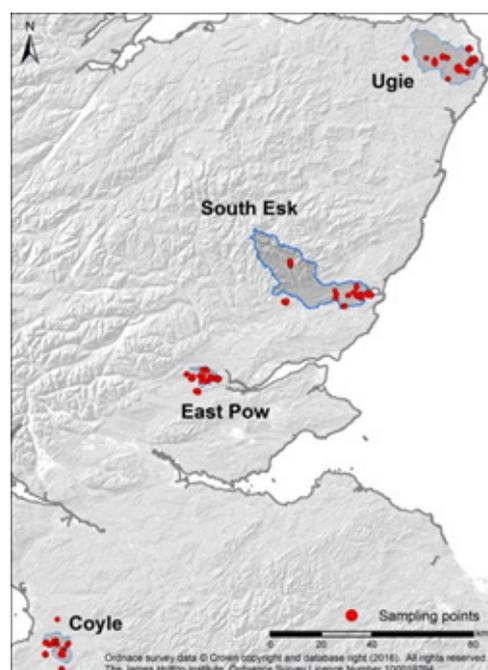
Figure 3 – Location of the four catchments sampled during this project and specific sampling locations. Symbols in red indicate sampling locations

The four catchments selected for detailed study were: Coyle, East Pow, South Esk and Ugie, with the sampling locations shown in Figure 3. The range of soil types in each catchment is shown in Figure 4.

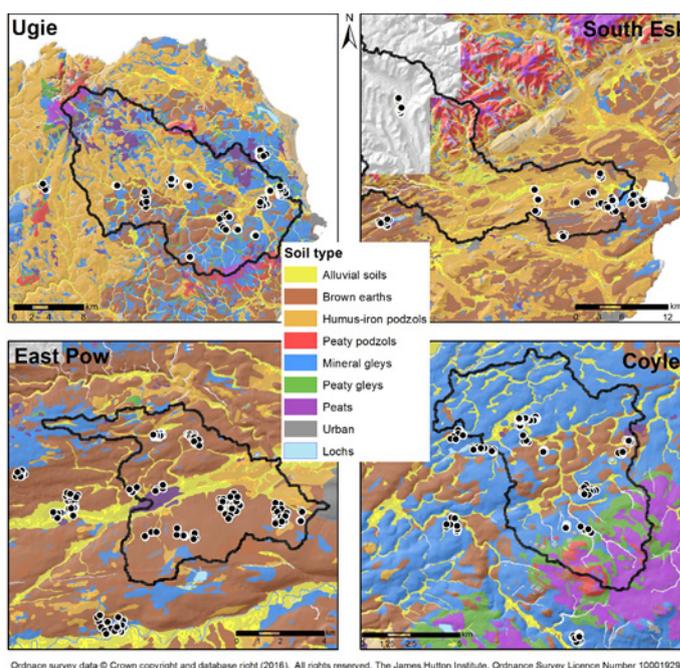
Figure 4 – Distribution of soil types (major soil subgroups) across the catchments.

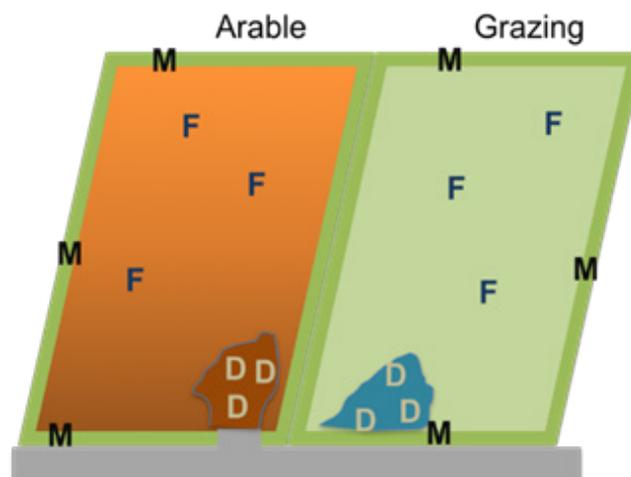
Figure 5 – Sampling locations in a typical Arable or Grazing field. The symbols refer to F – within the operation field, D – areas of heavy traffic that are visibly degraded on the surface, and M – less trafficked regions at the field margin. We refer to these areas as In 'Field', 'Margin' and 'Damaged', respectively in the remainder of the report.

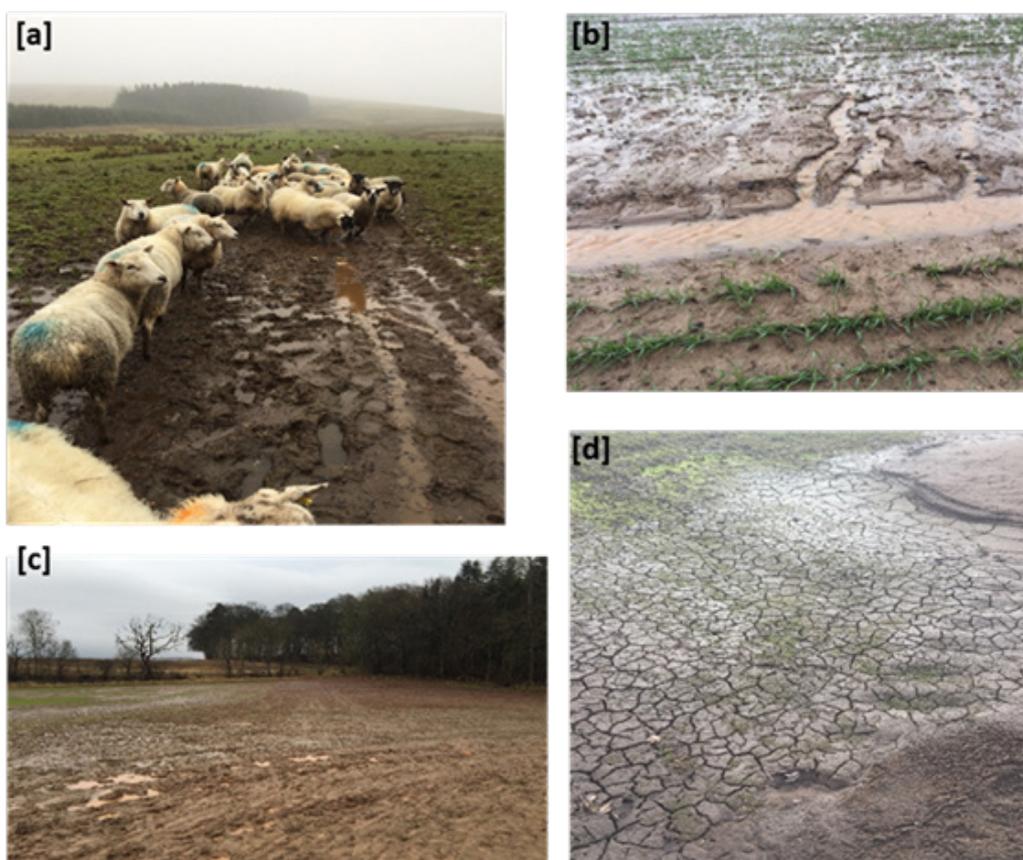
Figure 6 – Evidence of structural degradation of the surface soil [a].Poached topsoil [b] Topsoil erosion [c] Waterlogging [d] slaked topsoil

Evidence of structural degradation of the surface soil (compaction, erosion, capping etc. Figure 6) was recorded at the same time as the VESS and SubVESS assessments. Information on recent weather, soil drainage, soil plasticity and agricultural practices

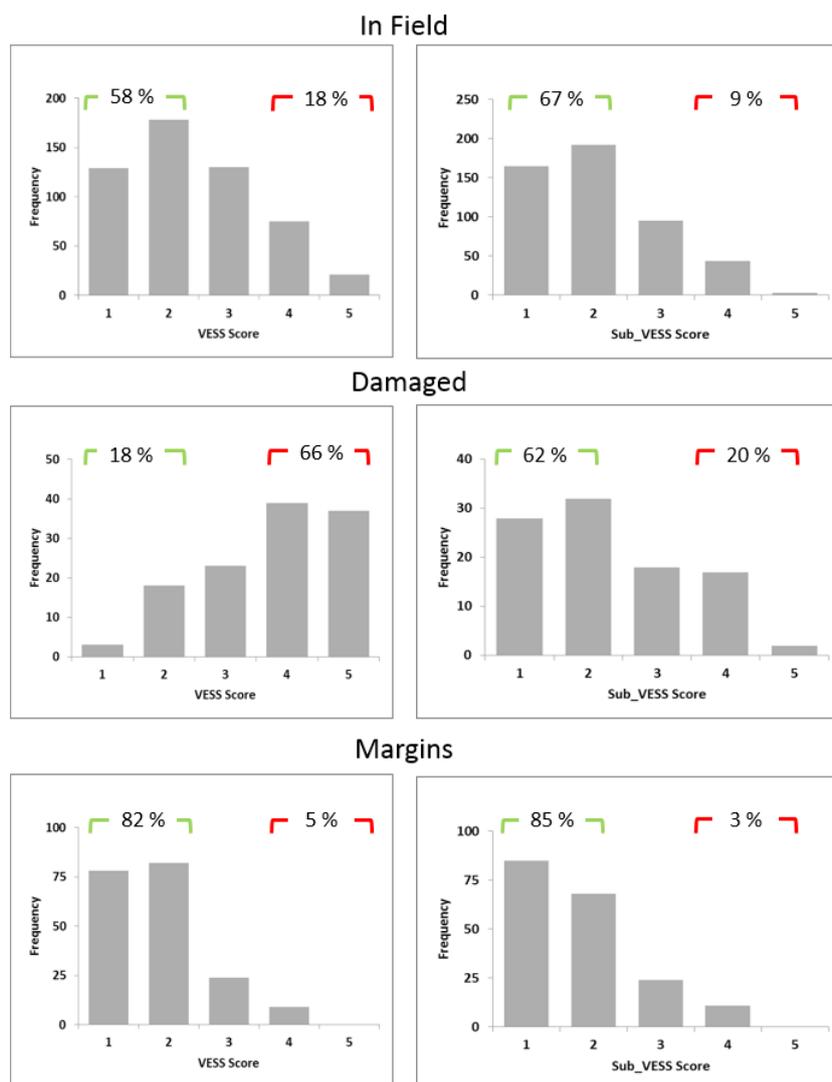
Figure 7 – Frequency distribution of the VESS and SubVESS scores for 'In-Field' (Top), 'Damaged' (Middle) and 'Margins' (Bottom). VESS and SubVESS ≤ 2 indicates good structural condition, whereas ≥ 4 indicates severe degradation.

However, we found severe soil structural degradation in 18% of topsoils (VESS scores of 4 or 5) and 9% of subsoils (SubVESS scores of 4 or 5) from within 533 'In Field' sampling locations. At the untrafficked field edges ('Margins') only 5% of topsoils and 3% of subsoils were severely degraded, giving evidence of soil structural degradation induced by farming practice. As expected, areas that were identified as 'Damaged' from a surface inspection had a much greater frequency of poor VESS scores. 'Damaged' areas also had more than double the proportion of poor SubVESS scores compared to 'In Field' locations, indicating a

link between surface damage and subsoil compaction. However, the proportions were much less than for VESS, with 62% of areas that are 'Damaged' at the surface having good subsoil structural quality (SubVESS scores of 1 or 2). It is essential to dig deep and survey to truly assess subsoil compaction. Although the proportion of sites with subsoil compaction appear small, the damage is very difficult to rectify and results in localised problems with drainage and crop productivity.

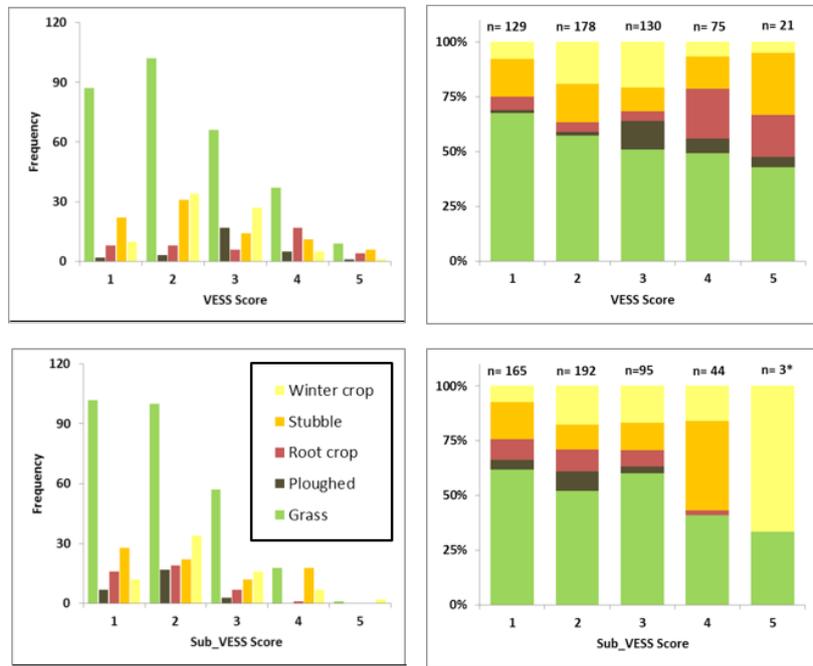
Figure 8 – VESS and SubVESS as affected by crop type in winter months. Only 'In Field' data are shown (See Appendix 5 for other data). 'In Field' refers to the main, productive area of fields. In the proportion graphs on the right, n is the number of locations where a measurement was made.

The 'In Field' results show degraded topsoil structure where root crops have been grown, with 49% of these topsoils having VESS scores of 4 or 5 (Figure 8). However, the majority of subsoils where root crops had been grown (81%) showed good subsoil structure (VESS scores of 1 or 2). In grasslands 63% of topsoils and 73% of subsoils assessed had VESS scores of 1 or 2 (Figure 8). Graphs showing differences by crop type in VESS and SubVESS scores in 'Damaged' areas and the 'Margins' are shown in Appendix 5.

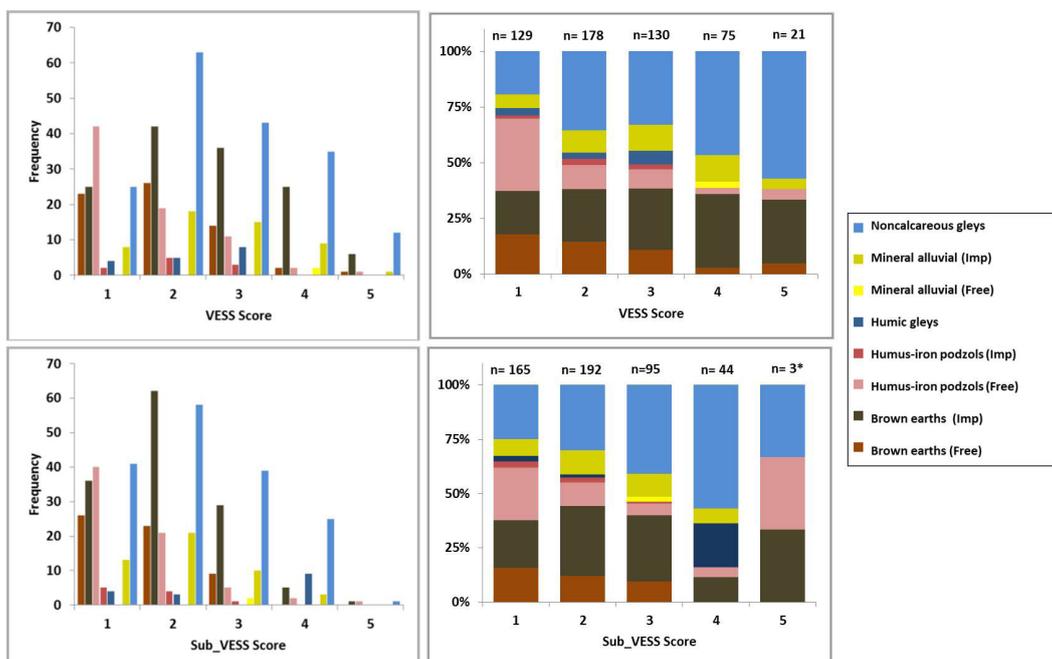
Figure 9 – VESS and SubVESS as affected by soil type in winter months. Only 'In Field' data are shown (See Appendix 5 for other data). 'In Field' refers to the main, productive area of fields. In the proportion graphs on the right, n is the number of locations where a measurement was made.

Expected trends in soil structure were found between soil types (Figure 9). Freely drained Podzols and Brown earths that are commonly associated with Scotland's best agricultural land had proportionally better soil structure than imperfectly or poorly drained soils, especially the Noncalcareous (mineral) gleys. In the subsoil, however, links between soil structure and soil type were less evident.

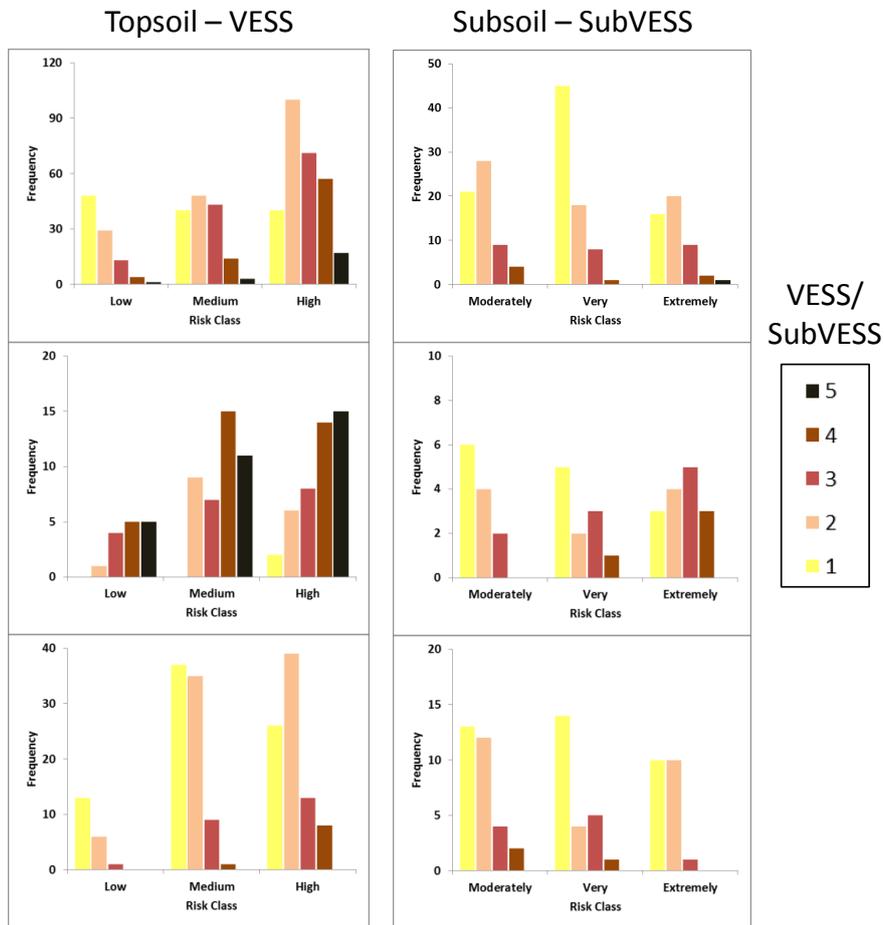
Figure 10 – Proportion of VESS (left) and SubVESS (right) falling under different topsoil and subsoil compaction risk classes, respectively. Each row of graphs corresponds to 'In Field' (Top), 'Damaged' (Middle) and 'Margins' (Bottom). Figure 2 describes the risk classes.

modelled risk classes (Figure 10). For subsoil compaction the trends are even less clear. For 'In Field' regions there appears to be little relationship between predicted subsoil compaction risk and the SubVESS score measured in the field. The modelling predicts the risk of subsoil compaction rather than its occurrence, so machinery history or good farm practice may have allowed some extremely vulnerable soils to retain good soil structure. In the 'Damaged' regions of fields, soils predicted to be extremely vulnerable to subsoil compaction had a greater occurrence of poor subsoil structure quality (SubVESS scores of 4 or 5).

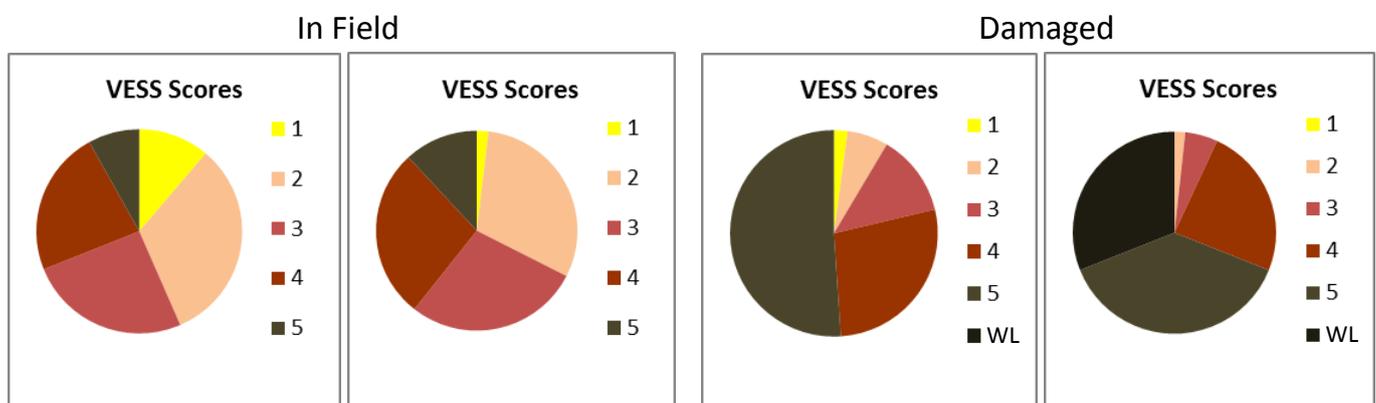
Figure 11 – Visual Evaluation of Soil Structure (VESS) based on 42 sites sampled before and after Scotland's historic rainfall event of December/January of 2015/2016. 1-5 refers to the VESS score with 'In Field' shown at the left and 'Damaged' areas of the field at the right. Waterlogged fields after the rainfall are shown as WL.

From the data presented in Figure 11, it is evident that the prolonged and intensive rainfall had a negative impact on soil physical structure. There was a 35% drop in sites with good topsoil structure (VESS of 1 or 2) for 'In Field' regions. In 'Damaged' areas of field good topsoil structure was rarely found and the severe rainfall resulted in a 46% increase in topsoils with poor structure (VESS of 4 or 5) or waterlogging that prevented resampling.

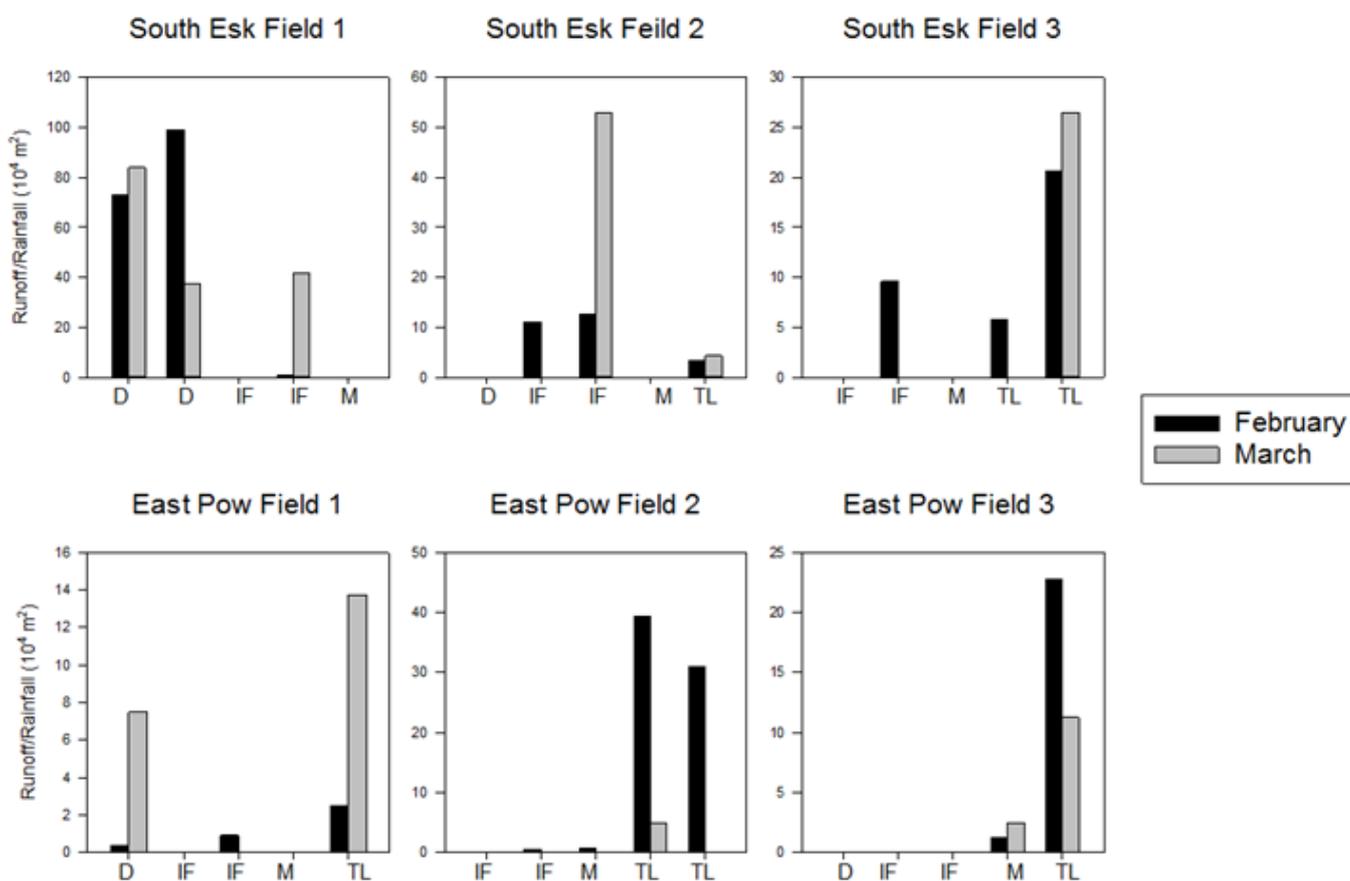
Figure 12 – Runoff/Rainfall as collected by unbounded Gerlach troughs in East Pow and South Esk catchments in different locations within a field based on the level of traffic. The symbols refer to IF – within the operation field, D – areas of heavy traffic or that are visibly degraded on the surface, M – less trafficked regions at the field margin, and TL as any areas with heavy traffic in main tramlines.

captured runoff and soil loss for a range of slope lengths/ contributing areas. The troughs were connected to a sealed tank to store water and sediment runoff. Runoff water samples were analysed to assess the likely impact on water quality based on their physio-chemical characteristics and compared with source soils (Table 1). Precipitation was measured with rain gauges located near to the Gerlach troughs.

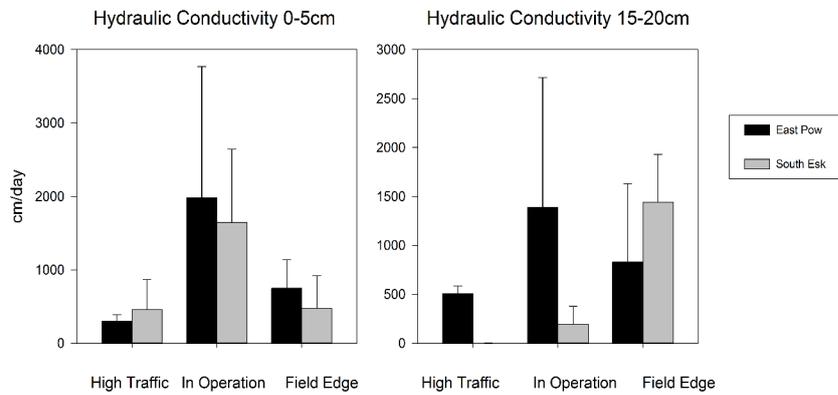
Figure 13 – Saturated hydraulic conductivities of intact core samples from both catchments.

We used saturated hydraulic conductivity as a measure of infiltration at the selected locations of the field (Figure 13). Results from both catchments indicate clearly that infiltration is fastest within the operational areas of the field (ANOVA, p<0.01). This corresponds with findings from Gerlach trough measurements as there is less runoff in most operational and margin samples (Figure 11).

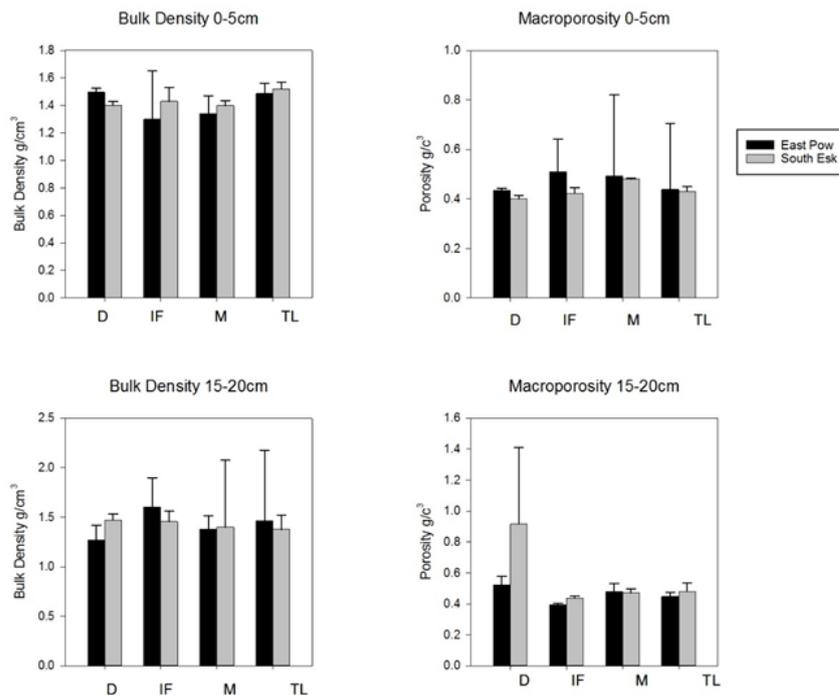
Figure 14 – Soil Physical properties of dry bulk density and soil macroporosity from intact soil cores from both catchments. The symbols refer to IF – within the operation field, D – areas of heavy traffic or that are visibly degraded on the surface, M – less trafficked regions at the field margin, and TL as any areas with heavy traffic on tramlines.

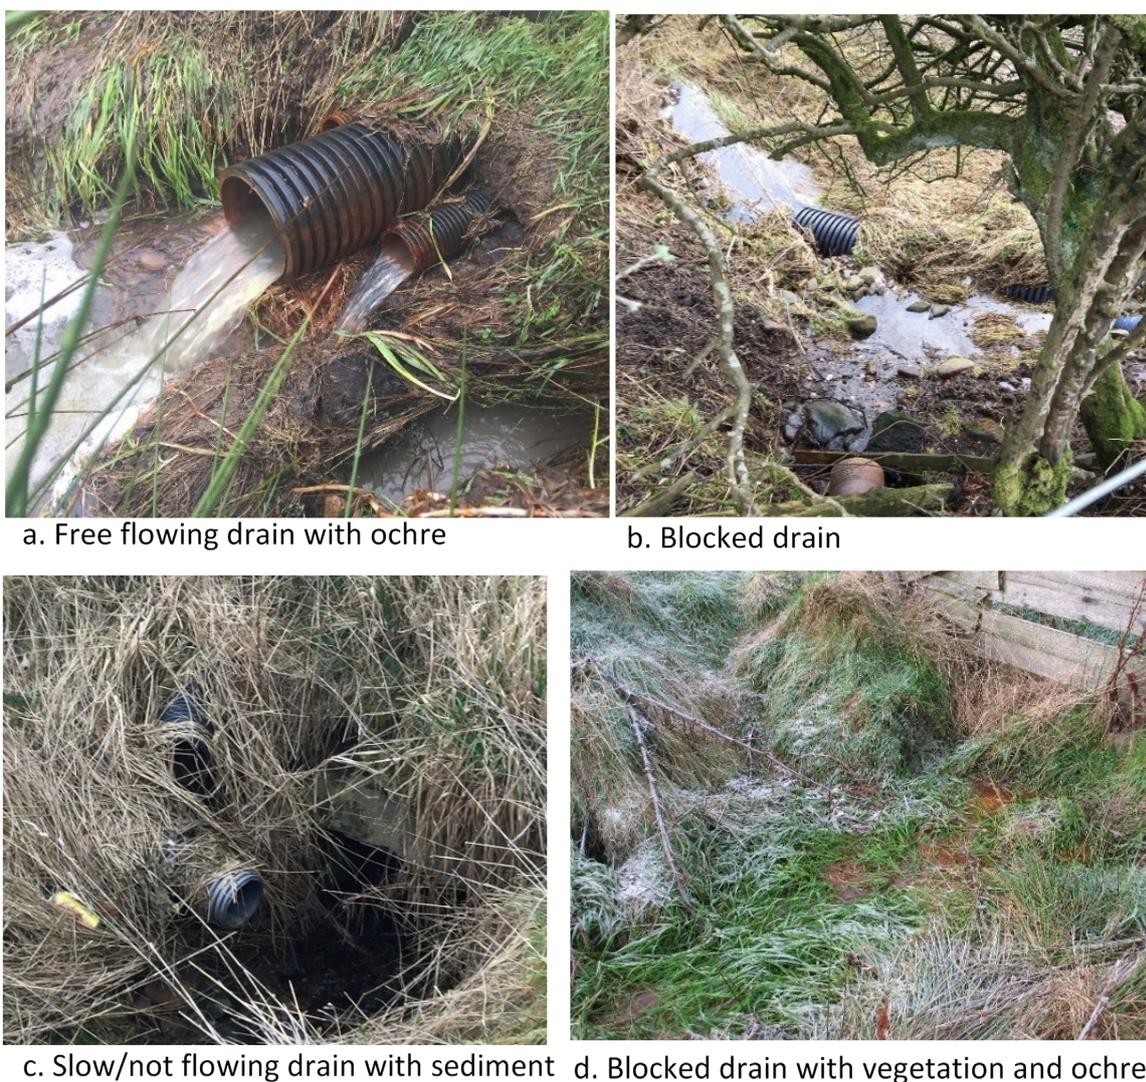
Figure 15 – Visual assessment of agricultural drains in ditches.

We also assessed the current state of agricultural drainage in the 120 fields surveyed. This examined sediment build-up and blocking of drains where they were visible in drainage ditches (Appendix 6). The photographs in Figure 15 illustrate differences found in the visual assessments of drainage outfalls, with the results summarised in Table 2. We also provided a questionnaire to farmers on their field drainage systems (Appendix 7), which we aimed to complete during the field visit. A total of 28 drainage questionnaires were completed by farmers and surveyors, results are shown in Table 3. A farm report template is given in Appendix 8.

Visual assessments of drainage outlets of each field showed a broad range of conditions and mainly free flowing drains. As drainage was mainly assessed in wet weather conditions the likelihood of finding outlets was increased, however as shown in Figure 15 blocked drains were difficult to identify. While 59% of the fields visually assessed showed functioning drainage outlets, there is a limitation to the study as drains may have been missed.

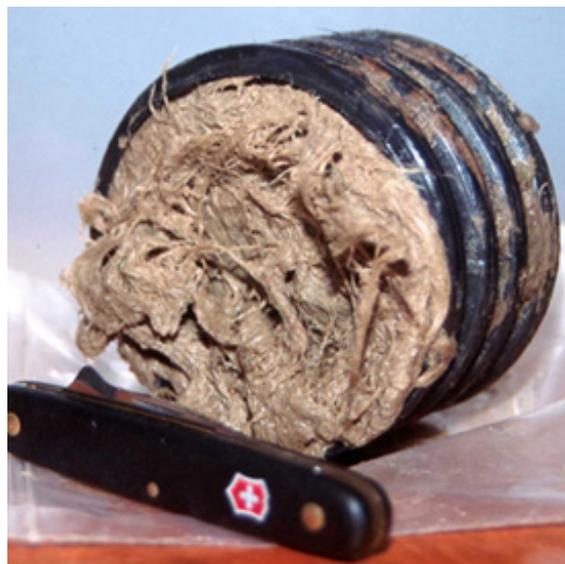
Figure A1:1 – Agricultural drains can be blocked by a mix of roots and soil. Source: Leuty (2012).

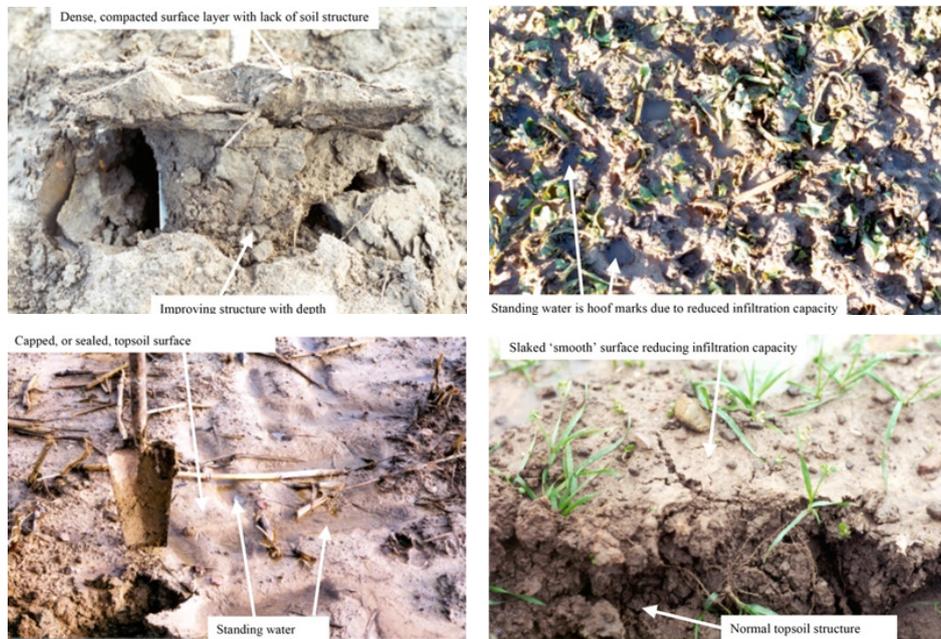
Figure A1:2 - Holman et al. (2002) observed (from top left clockwise) compacted topsoil, hoof damage with standing water, surface slaking and surface capping indicating soil structural degradation in four UK catchments.

For late harvested crops, however, the incidence was 55%. Photographs from their report illustrating soil structural degradation are shown in Figure A1:2. By combining their new data with the National Soil Map of England and Wales, a simple model (HOST) predicted increases in runoff water reaching rivers of 0.5 to 12%. Although this represents a significant increase, which suggests greater flood risk, Holman et al. (2002) were cautious about inferring too much from this desk-based study.

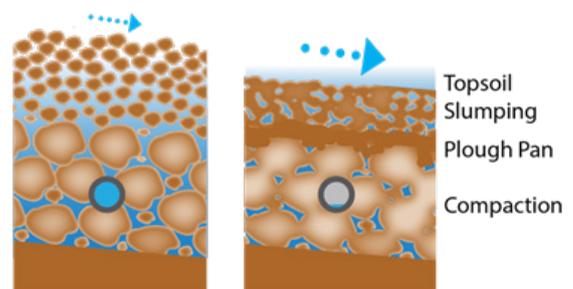
Figure A1:3 - The physical structure of soil can degrade through inter-linked processes of compaction, slumping and the effectiveness of artificial drainage.

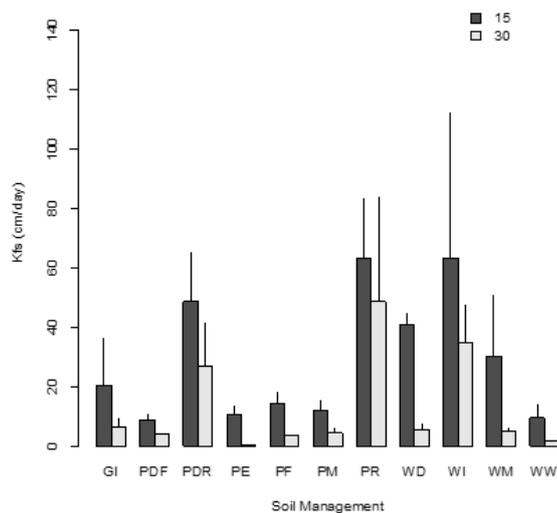
Figure A1:5 - A preliminary trial of the Guelph Permeameter in South Esk did not detect differences 'In Field' hydraulic conductivity, Kfs, between contrasting soil treatments including wheelways (WW) and in-field (WI) for winter wheat. Three replicates were measured per treatment.

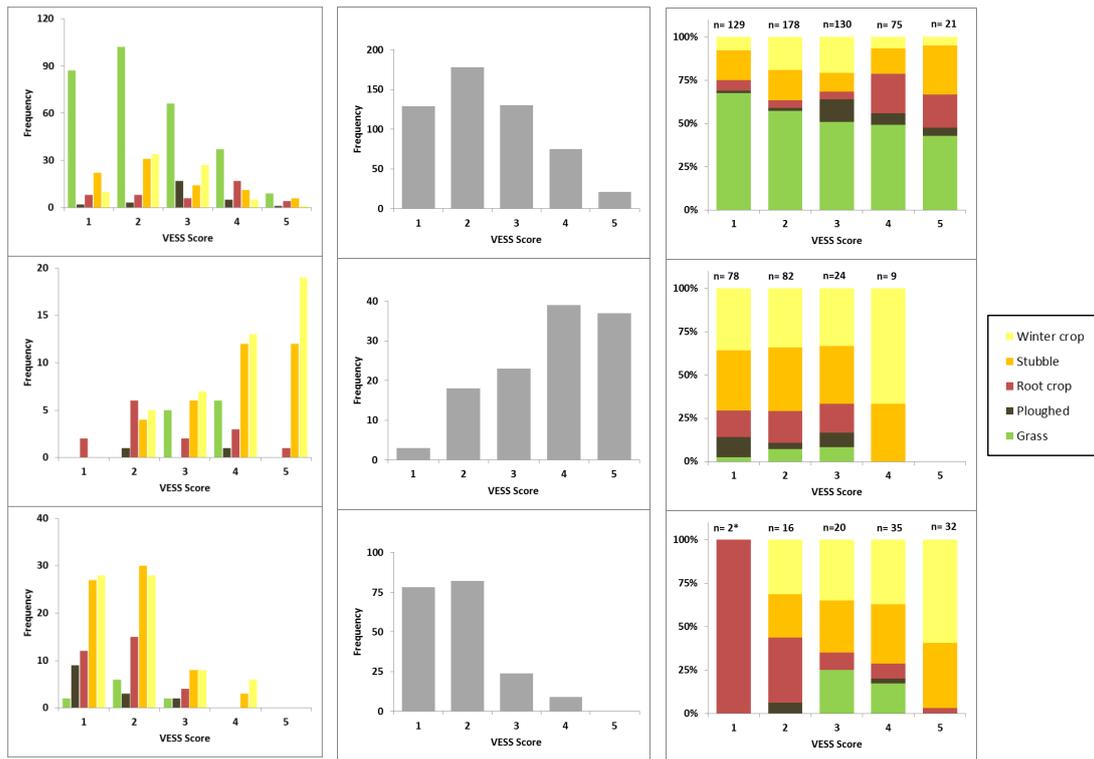
Figure A5:1: Frequency distribution of the VESS scores separated by cropping practice for 'In Field' (Top), 'Damaged' (Middle) and 'Margins' (Bottom). VESS ≤ 2 indicates good topsoil structural condition, whereas ≥ 4 indicates severe degradation.

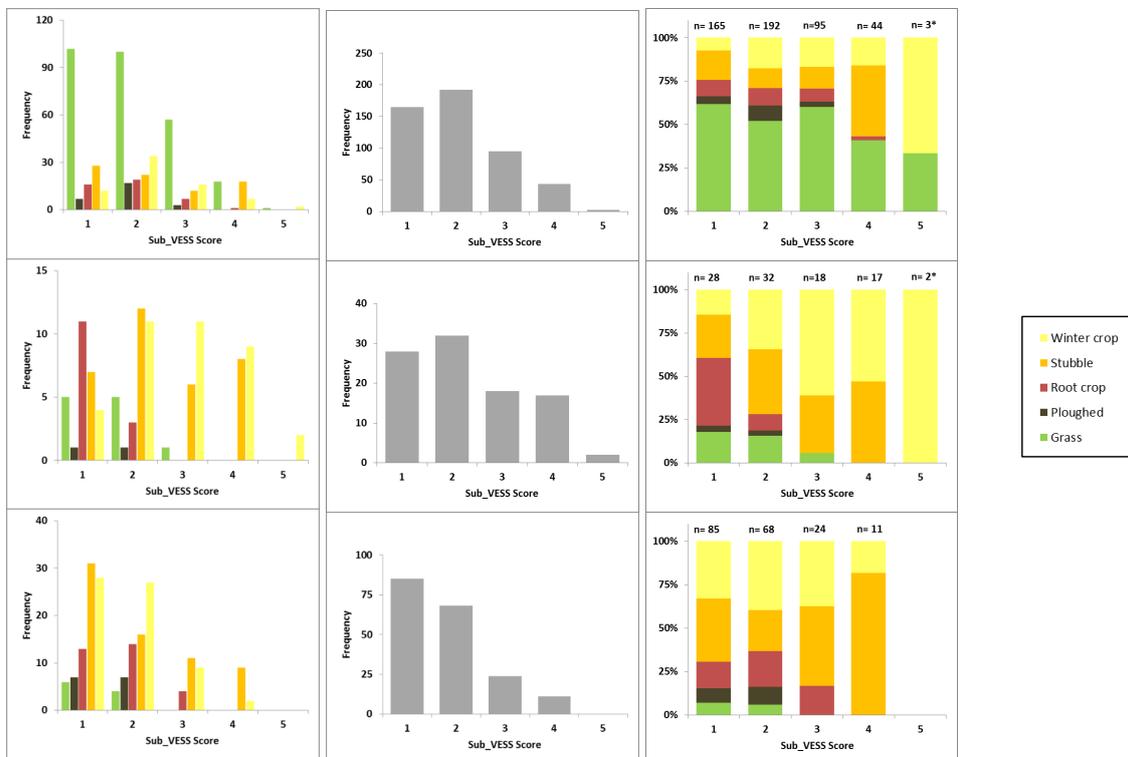
Figure A5:2 - Frequency distribution of the SubVESS scores separated by cropping practice after the extreme December/January precipitation for 'In Field' (Top), 'Damaged' (Middle) and 'Margins' (Bottom). SubVESS ≤ 2 indicates good subsoil structural condition, whereas ≥ 4 indicates severe degradation.

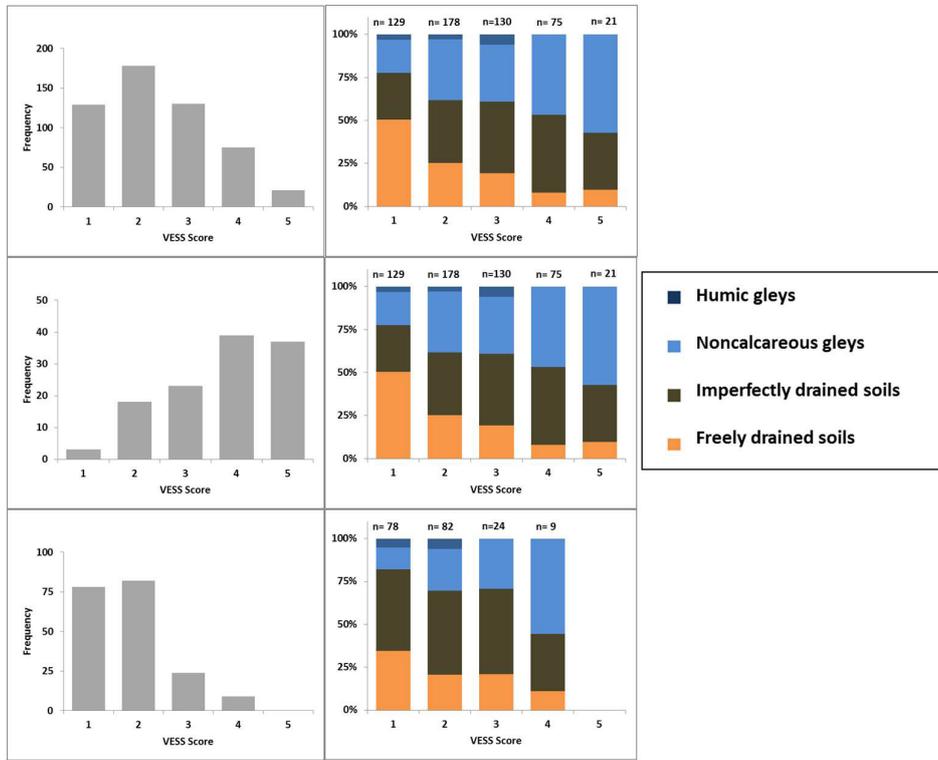
Figure A5:3 - Frequency distribution of the VESS scores separated by major soil types for 'In Field' (Top), 'Damaged' (Middle) and 'Margins' (Bottom). VESS ≤ 2 indicates good topsoil structural condition, whereas ≥ 4 indicates severe degradation. Imperfectly and freely drained soils includes Podzols and Brown earths.

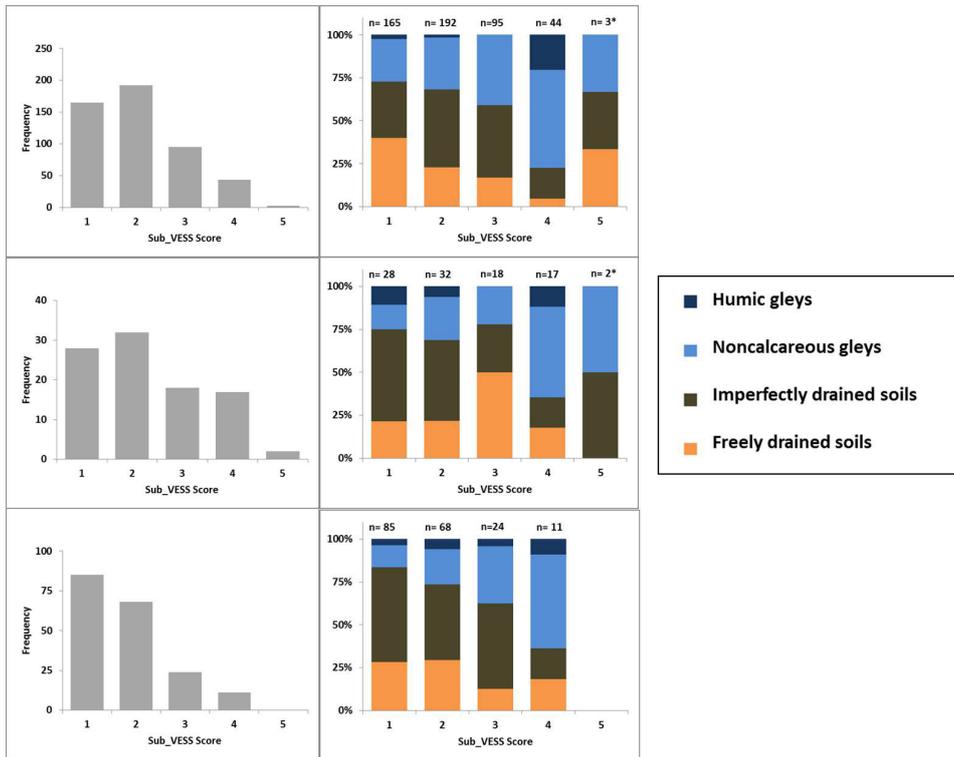
Figure A5:4 - Frequency distribution of the SubVESS scores separated by major soil types after the extreme December/January precipitation for 'In Field' (Top), 'Damaged' (Middle) and 'Margins' (Bottom). SubVESS ≤ 2 indicates good subsoil structural condition, whereas ≥ 4 indicates severe degradation. Imperfectly and freely drained soils includes Podzols and Brown earths.

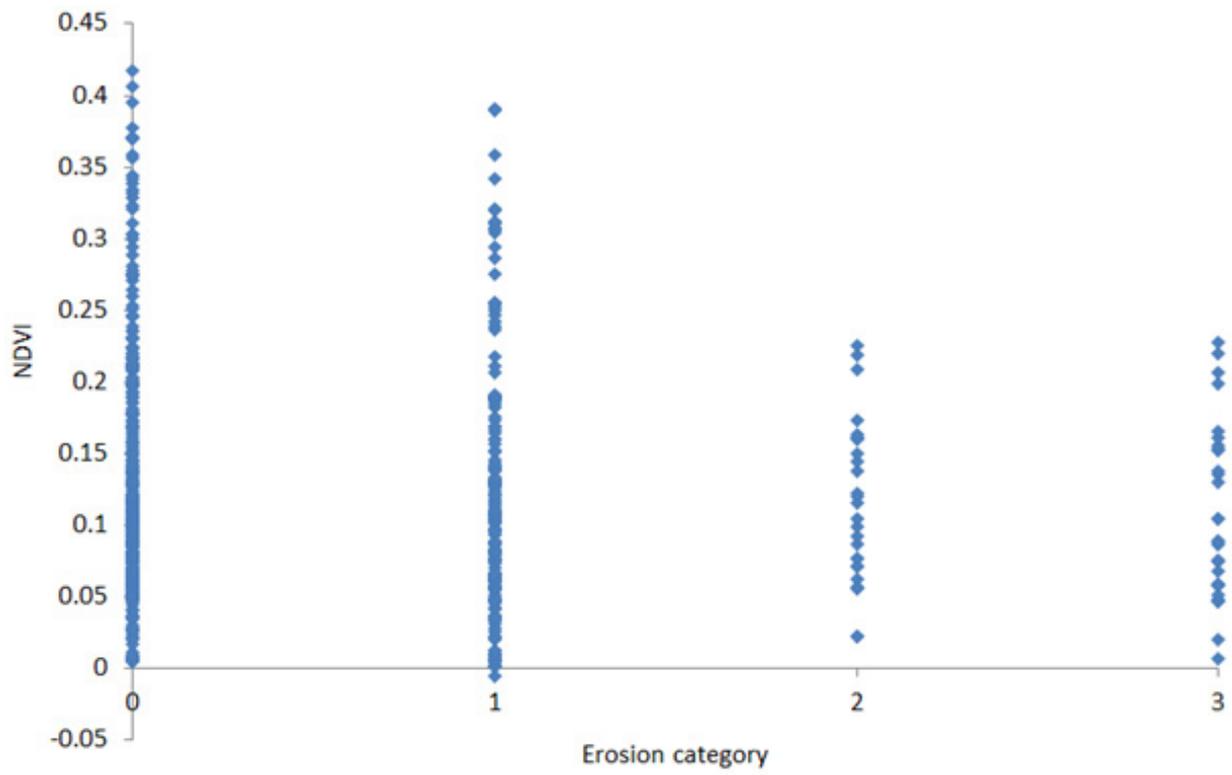
Figure A9:1 - Erosion category to NDVI, with higher values indicating greater erosion.

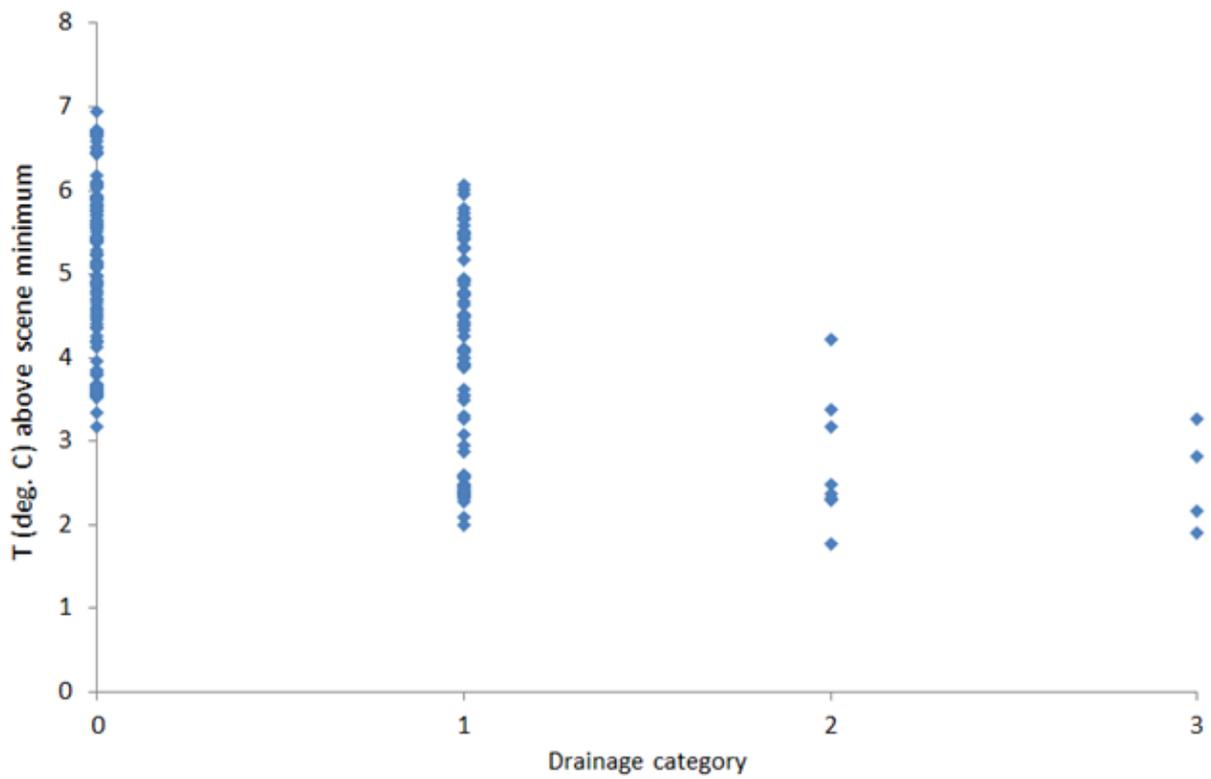
Figure A9:2 - Relationship between drainage category and temperature above local minimum, with higher

Figure A9:2 shows the relationship between estimated temperature (expressed as the difference between pixel temperature and the elevation-adjusted scene minimum) and soil drainage category, with higher values of drainage category indicating poorer drainage. This shows a definite relationship between temperature (and therefore moisture content) and drainage category, with poorer drainage being colder and therefore wetter. There is a lot of variation visible within the temperatures seen at each drainage category, and it is assumed that a number of other factors are important (such as soil texture and slope/aspect).
