NON-TECHNICAL SUMMARY DUNRUCHAN FARM PEATLAND RESTORATION PROJECT LESSONS LEARNED

Lawrence Belleni
RIVER FORTH FISHERIES TRUST
106 Biggar Road, Edinburgh, EH10 7DU

Dunruchan Farm Peatland Restoration Site

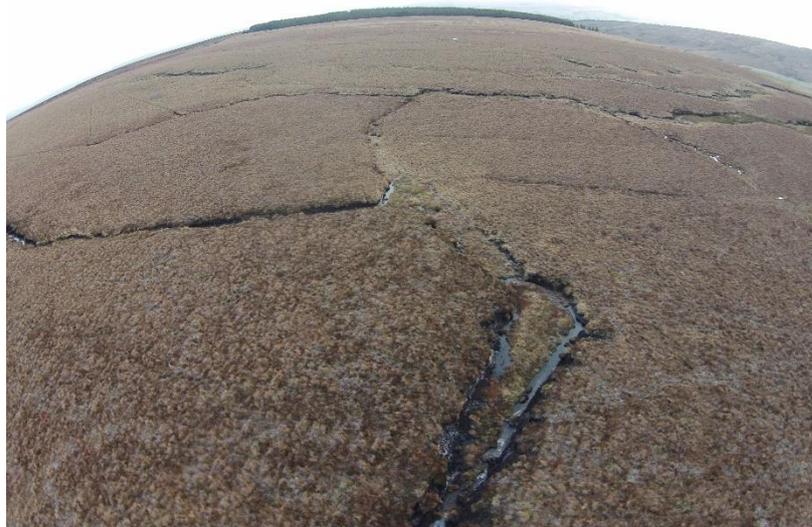
Figure 1 Dunruchan Farm Peatland Restoration site before physical works.

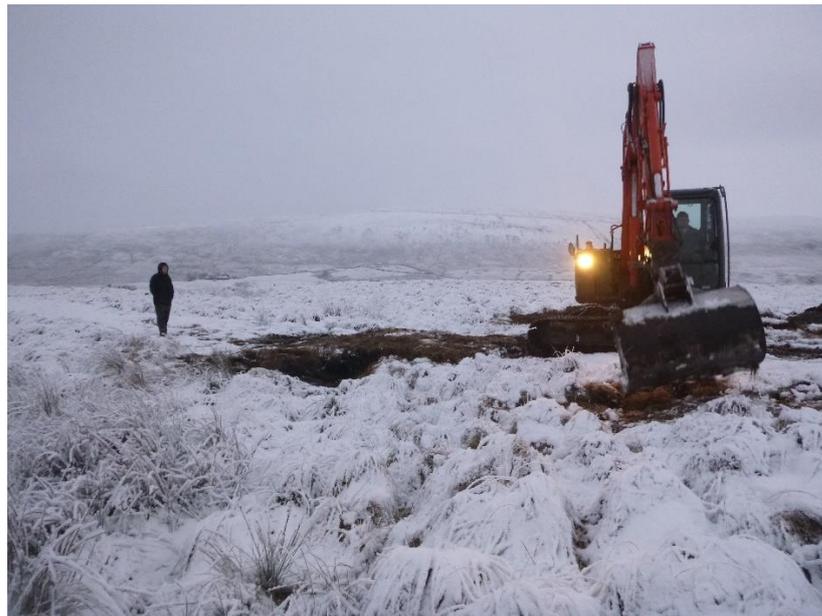
Figure 4 Contractor correcting a culverted crossing that was installed at the wrong location due to miscommunication.

Communication misunderstandings can be problematic to the efficiency of the project delivery. The project manager's time can be taken up ensuring the contractor's off-site project manager and on-site site foreman communicate with each other and are both able to provide an accurate answer relating to the delivery of the project. In addition, when the original tender project plan changes, it is paramount that the project manager and contractor communicate closely on works that are outside of the original project plan. If the contractor carries out work that was not desired and/or incorrectly placed due to lack of communication the efficiency of the project delivery is reduced as time is consumed correcting the work.

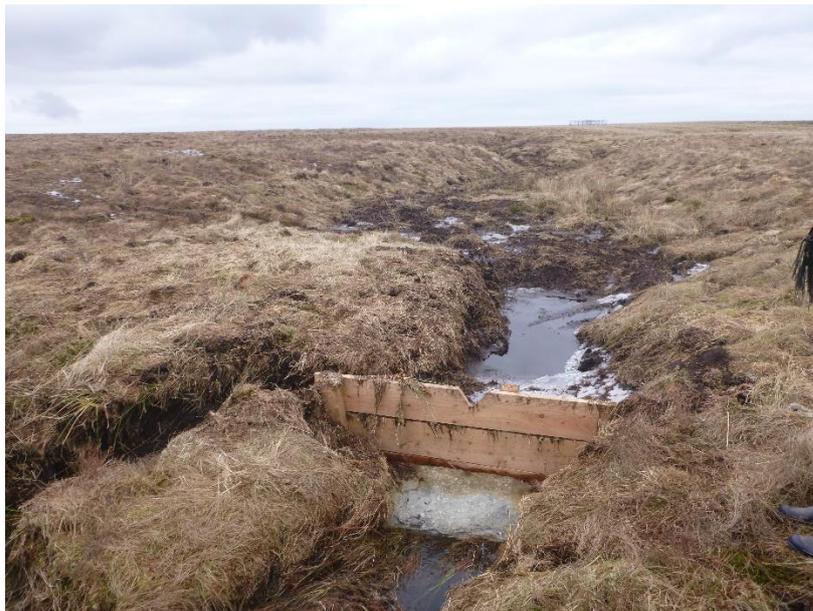
There were issues within a couple of weeks of the contractor having left the site due to inappropriate wooden sediment trap specifications for the peatland restoration site, which resulted in two of the wooden sediment traps failing. One of the wooden sediment traps had failed previously while on site and had had an attempted repair carried out on it but the repair had not lasted. Key reasons for the wooden sediment traps failing were:

- The boards were not built deep enough into the banks either side of the gully;
- V-notches that were put into the structures were not large enough to cope with the amount of water behind the structure;
- splash plates were inadequate and didn't cover the full base of the structure resulting in scour;
- and wooden sediment traps were sitting higher than the bank on one or either side of the trap, resulting in the water eroding a bypass channel around the structure.

Figure 5 A wooden Sediment trap that failed not long after the contractor left site due to the design of the trap for the location. As viewed in the picture, water has eroded around the wooden sediment trap through the left bank creating a bypass channel and making the trap redundant.

The project found this unacceptable and was able to get the contractor to return to site to fix and improve each wooden sediment trap to an appropriate standard that the project was confident in. The contractor returned to the site and installed larger U-shaped water release notches; ensured the trap was not higher than the bank height and amend it if it was; extend the top horizontal plank into the bank at least 0.6m either side; and where required add additional vertical posts for support to structures that were previously compromised. Following the completion of this work the PO was pleased that the wooden sediment traps were robust enough and should not require maintenance or cause the LO a negative experience.

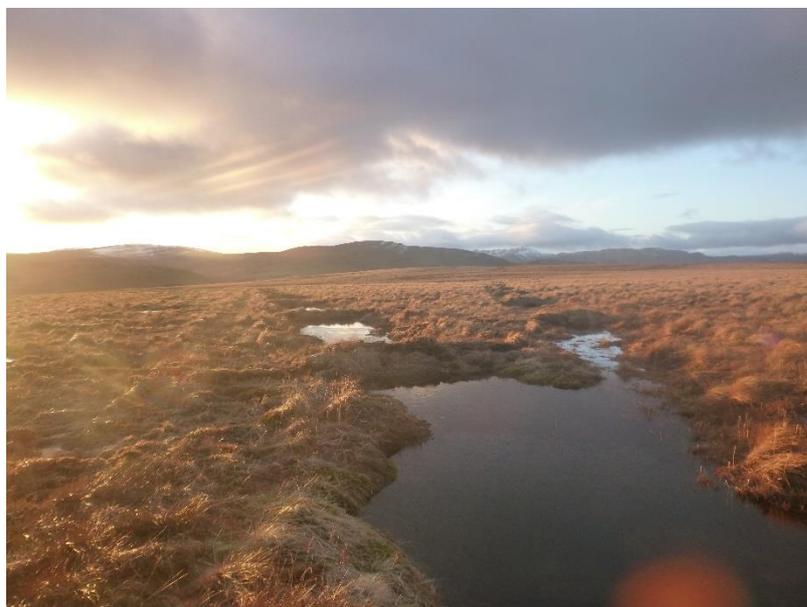
Figure 6 The completed Dunruchan Farm Peatland Restoration Project site.
