# The Bowmont catchment initiative: **An assessment of catchment hydrology and Natural Flood Management measures**

Four year summary

**Stephen Addy & Mark Wilkinson** February 2017

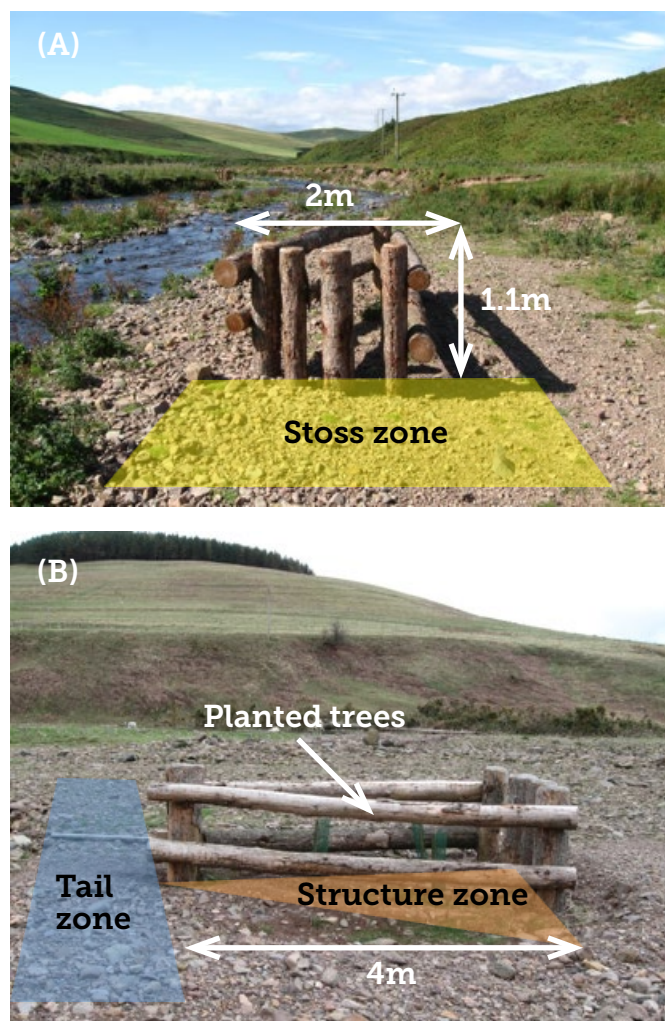
Figure 18: Typical dimensions of the bar apex log jam design constructed in the Bowmont valley and definition of zones used to analyse morphological change associated with the structures. (A) Front end view of log jam S5 at Swindon Haugh. (B) Profile view of log jam S12 at Swindon Haugh.

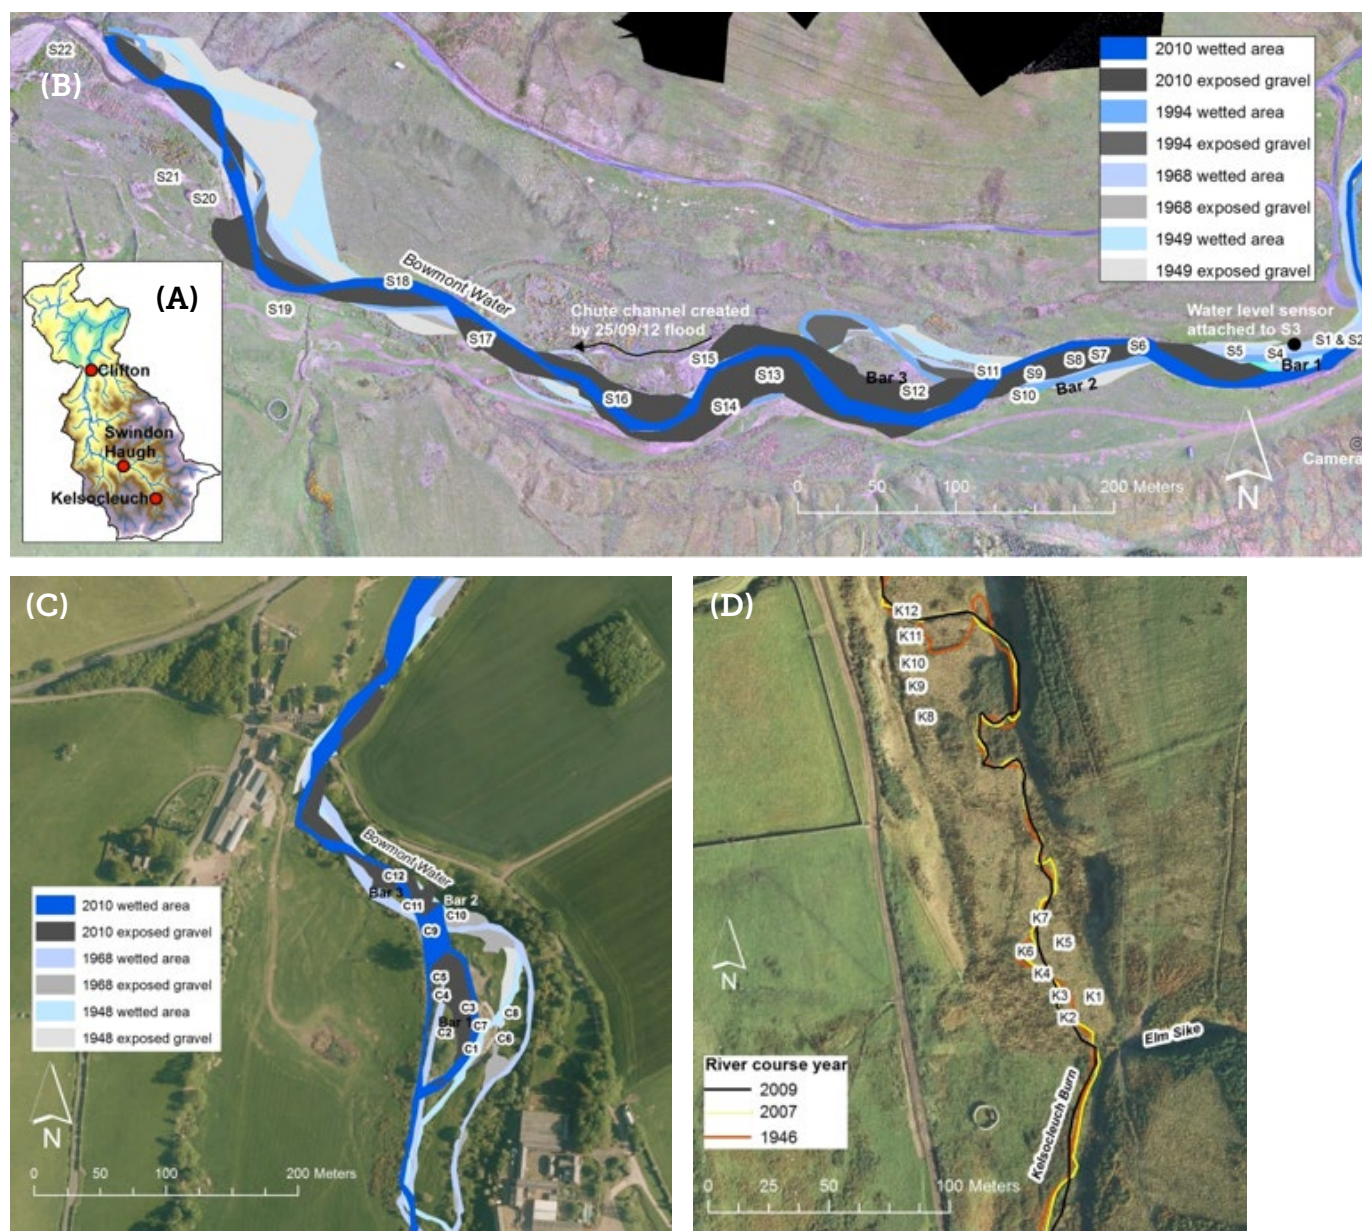
Figure 19: Locations of bar apex ELJ study sites. Locations of the bar apex ELJs and river planform characteristics over time at (B) Swindon Haugh (May 2013 UAV aerial background image shown for reference), (C) Clifton (2007 aerial photograph: Copyright Getmapping plc.) and (D) Kelsocleuch Burn (2007 aerial photograph: Copyright Getmapping plc.).

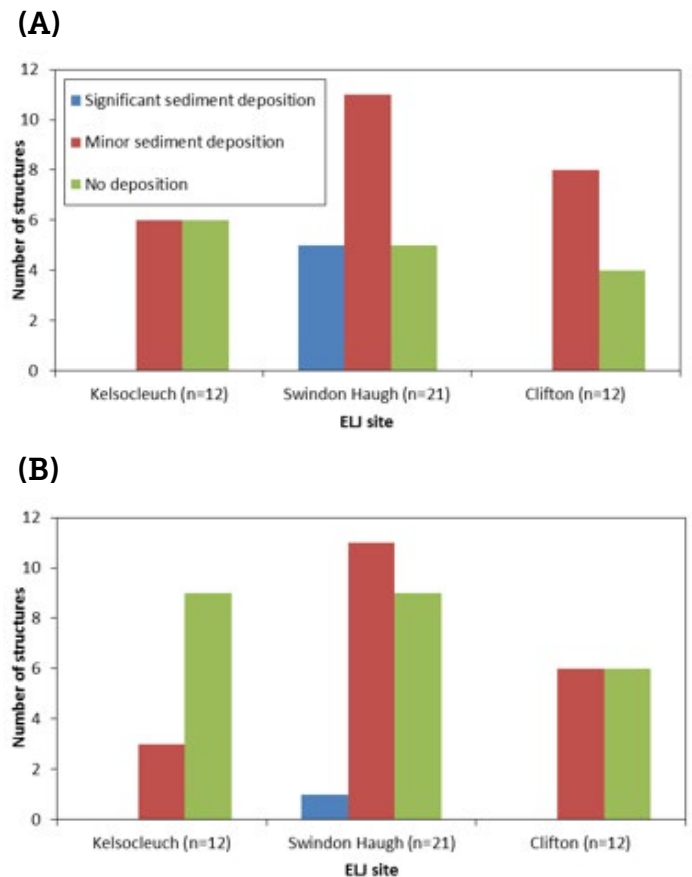
- Large (> +0.3 m depth) sediment deposition is associated only with a limited number of structures restricted to Swindon Haugh and mostly in response to the September 2012 flood event (Figure 22). The large sediment deposition around these structures partly reflects the re-accommodation of sediment in the bars after gravel management was undertaken in 2009 rather than simply the presence of the structures.

- For both flood events considered, the majority of structures were associated with minor sediment deposition (< 0.3 m depth) suggesting the structure design and their placement are insufficient to capture significant volumes of sediment (Figure 22).

Figure 22(A): Sediment capture effectiveness in response to the (A) September 2012 and (B) January 2016 flood events. Significant sediment deposition is defined as over 0.3 m in height of material deposited (> mean natural deposition thickness of 0.25 m caused by the September 2012 flood at Swindon Haugh) and minor deposition defined as less than 0.3 m of deposition. No deposition defined when no signs of deposition were observed.

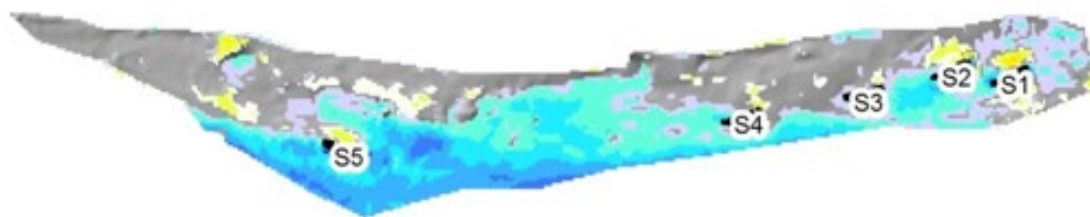
**Bar 1 Net volume change: +87 m<sup>3</sup>**

Figure 23: Distribution of elevation changes showing erosion and deposition response for Bars 1 to 3 at Swindon Haugh between August 2012 and October 2012 (see Figure 19(B) for locations of bars). Hill-shaded topography map (based on August 2012 survey) shown in the background for context.

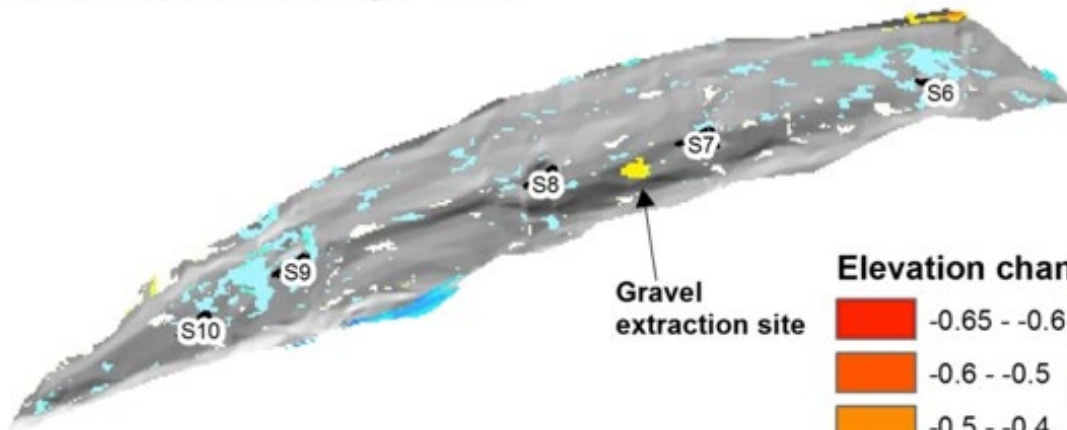
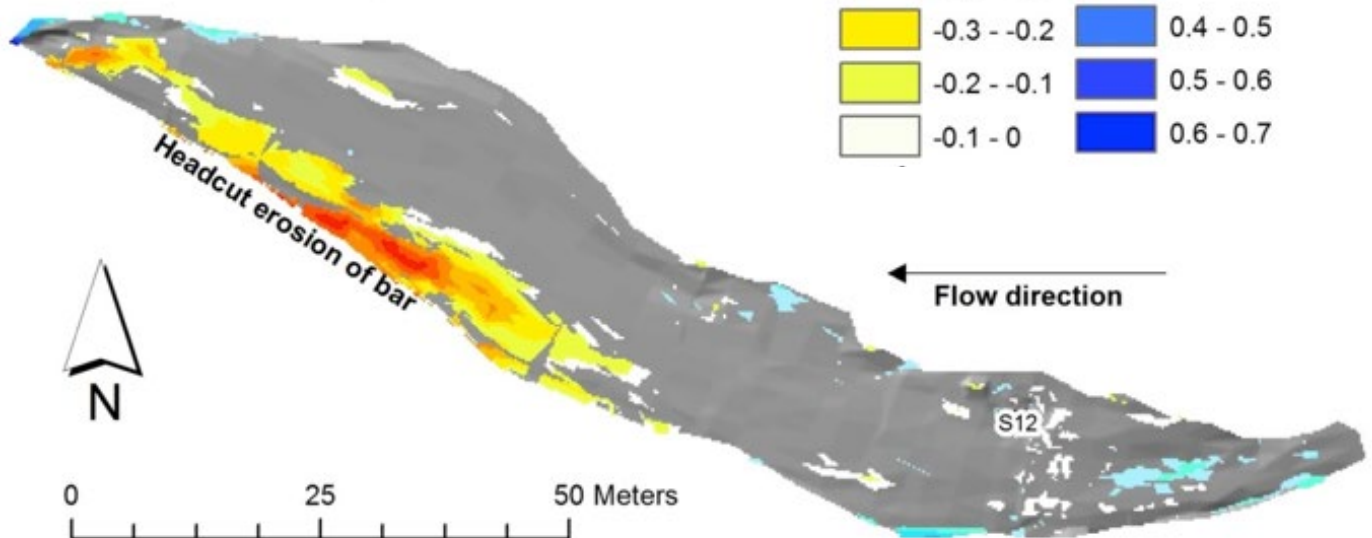
Figure 24: Distribution of elevation changes showing erosion and deposition responses for Bars 1 to 3 at Swindon Haugh between July 2015 and March 2016 (see Figure 19(B) for locations of bars). Hill-shaded topography map (based on July 2015 survey) shown in the background for context.

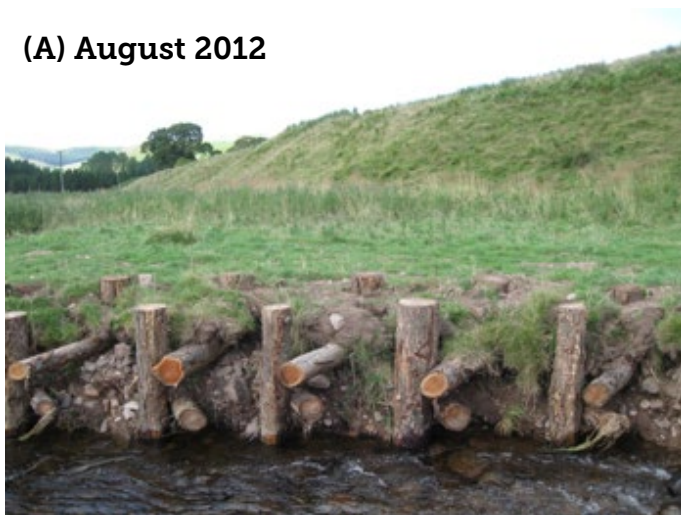
**(A) August 2012**

Figure 27: Downstream section of Structure 1 between August 2012 and March 2016. Note the erosion of placed gravel backfill and turf followed by progressive erosion of the bank.

- The structures have remained intact over time and show no signs of displacement (Figure 27). The backfill has been removed in places especially at Structure 1.
- Vegetation has encroached on to the bar surfaces indicating favourable growing conditions probably aided by the paucity of high flows that can disrupt plant colonisation during the monitoring period (Figure 28). This matches observations from other sites and is unlikely to be related to the presence of the structures.
- A large number of small fish (parr and fry?) were observed using the reach especially in the pool in between the two structures. It is not clear if structures have improved cover for the fish making the reach more attractive or if the pool - which reflects natural processes rather than the effect of the structures – offers particularly attractive habitat.

- Consideration should be given to the strength of any backfill and turfs used to provide further bank reinforcement after structure installation; loose backfill doesn't stay in place in all settings and continued grazing prevents the development of natural vegetation that increases resistance.

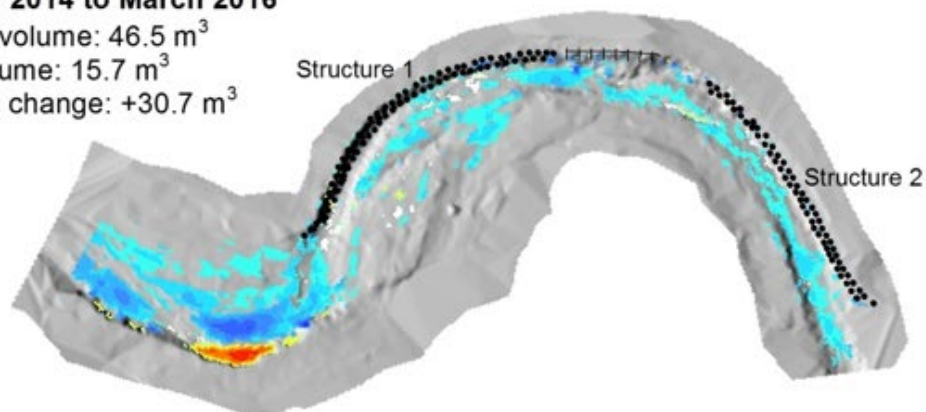
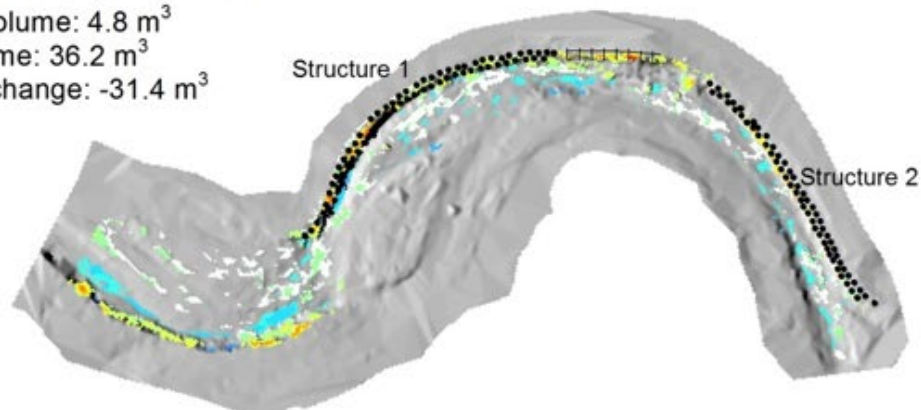
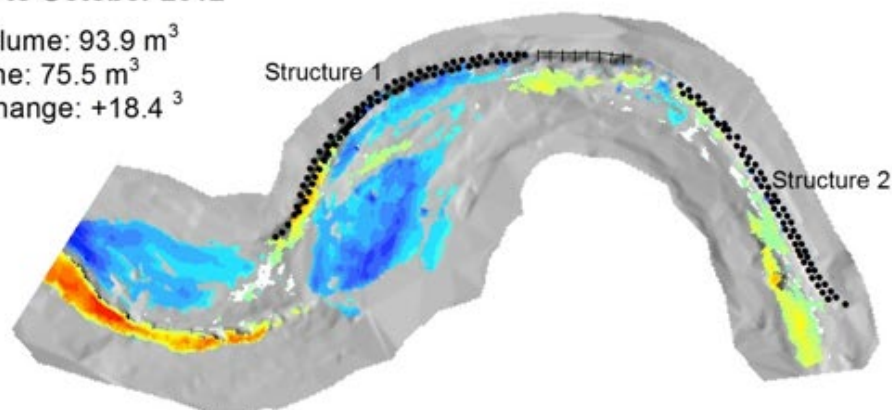
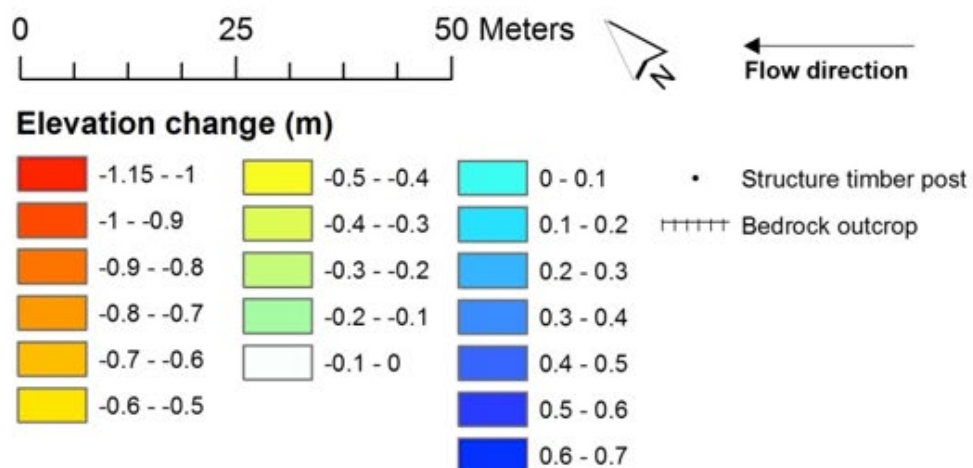
- Between August 2012 and October 2012 the greatest geomorphic changes were recorded over the 4 year period. This reflects the significant flood event that occurred on the 25th of September 2012 (Figure 29). Overall there was a net gain of sediment during this period. Notably, up to nearly 0.7 m of deposition occurred over existing bars and a new medial bar which developed close to Structure 1. Up to 4 m of riverbank was eroded (lateral direction) in the downstream portion of the reach. Vertical erosion of up to nearly 0.8 m of the bed was associated with Structure 1 indicating the flow deflection effect of the structure (Figure 29 and Figure 30). A considerable amount of the backfill was eroded during this event at Structure 1. In contrast change close to Structure 2 was less marked but bed scour possibly caused by the structure and some erosion of backfill occurred towards its downstream end.

- Between October 2012 and September 2014, geomorphic changes were minor reflecting the moderate flows during this period (Figure 29). Erosion of structure backfill continued during this period and overall there was a net loss of sediment.

- In the final period between September 2014 and March 2016, there was a net gain of sediment which has been deposited widely over the channel bed and bars (Figure 29). Much of this sediment gain is likely to be associated with the 5th of January 2016 flood. Scour of backfill, banks and stream bed adjacent to the structures was limited. Up to 2 m (lateral direction) of riverbank downstream of the structures was eroded during the period.

Figure 29: Topography and sediment volume changes at the Kelsocleuch bank protection structure monitoring site for three periods between August 2012 and March 2016. Underlying hillshade topography maps dated to the first survey of each period.

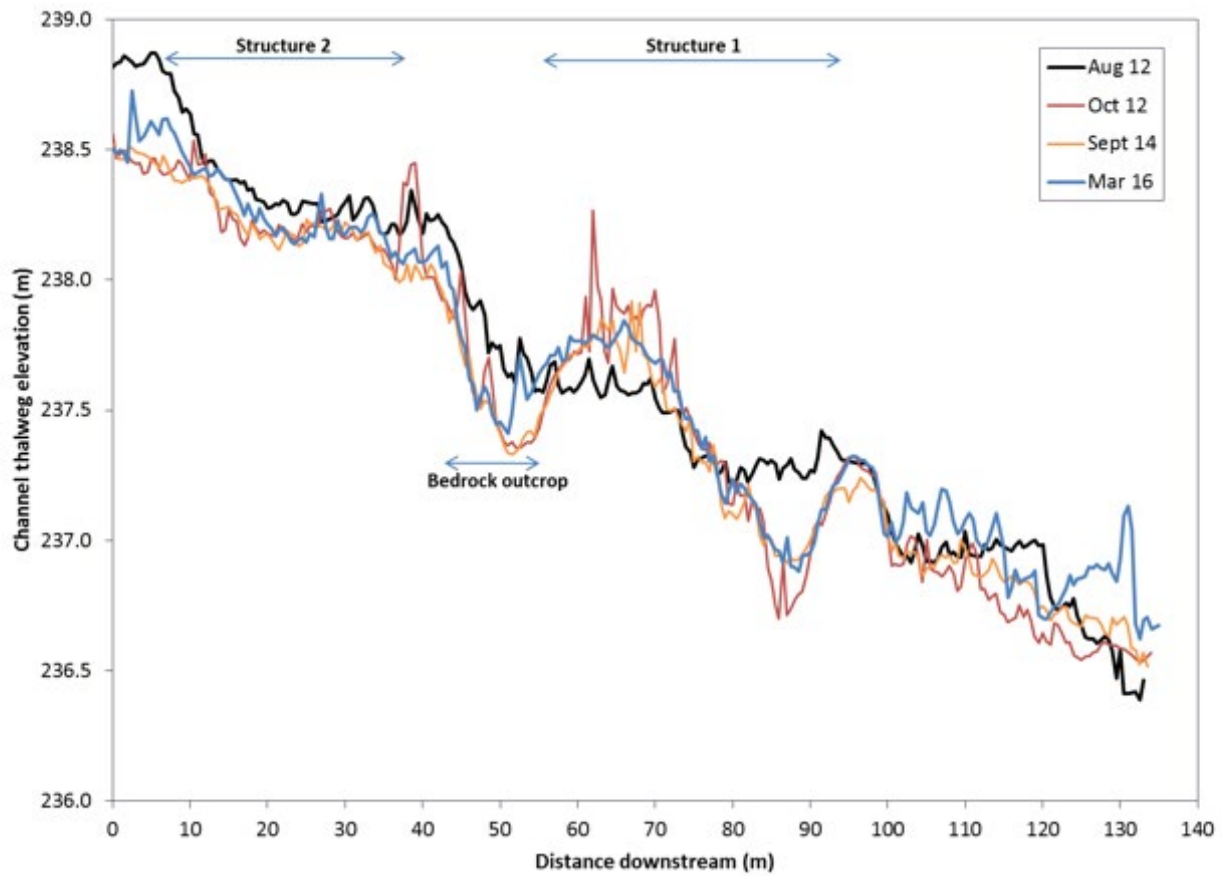
Figure 30: Channel elevation profile along the deepest part of the riverbed (thalweg) adjacent to the log structures between August 2012 and March 2016.

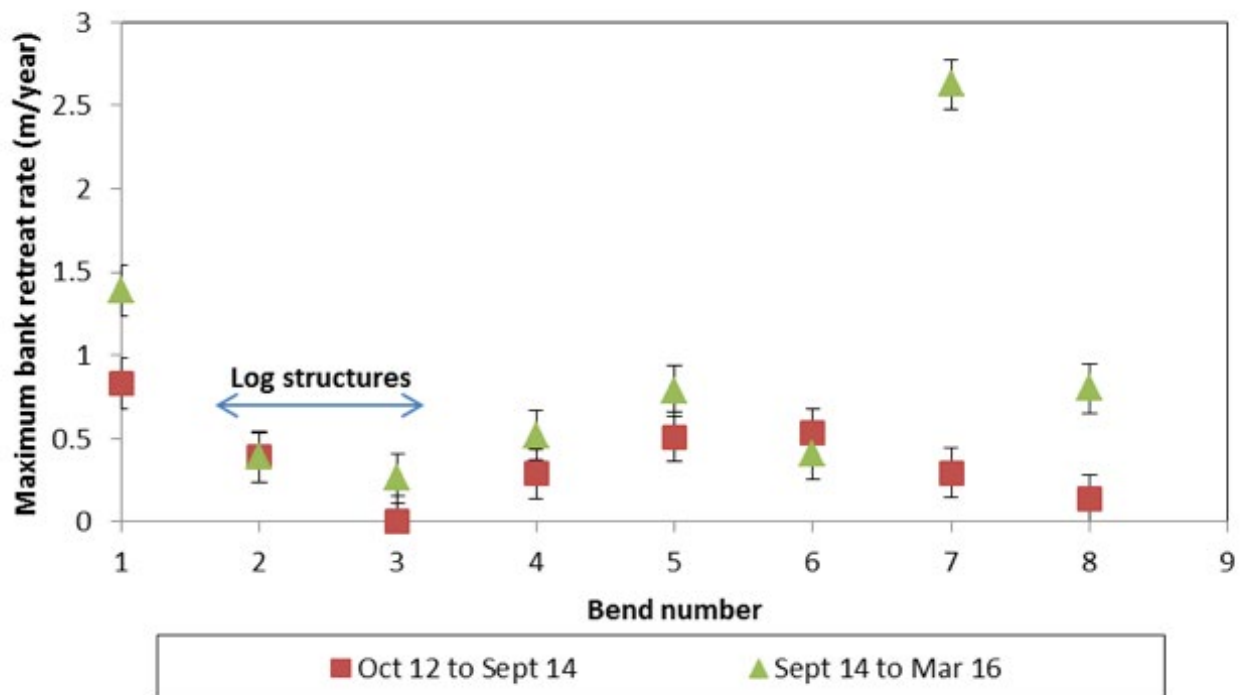
Figure 31: Maximum bank erosion rates at channel bends adjacent to and upstream or downstream of the bank protection log structures. Bend numbers in an upstream ascending order. 0.15 m error bars indicate uncertainty of erosion rates due to assumed potential survey point error for recording the location of eroding bank edges.

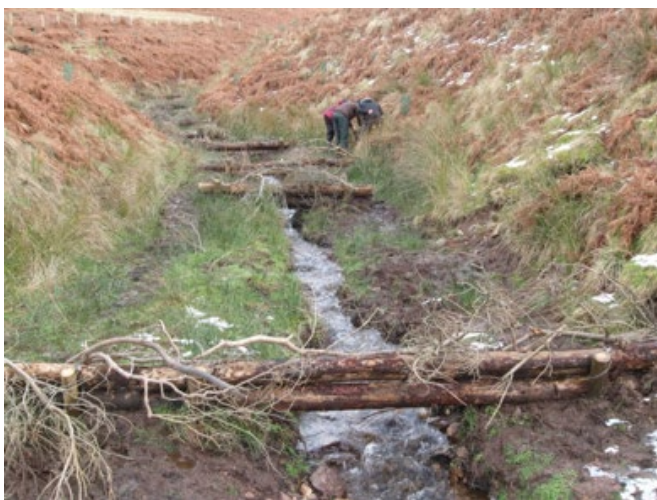
Figure 35: Flow restrictor S1 in the foreground photographed in February 2014 with structures S2 to S8 in the background. Note the gap (minimum of 0.3 m) below the timbers to facilitate fish passage.

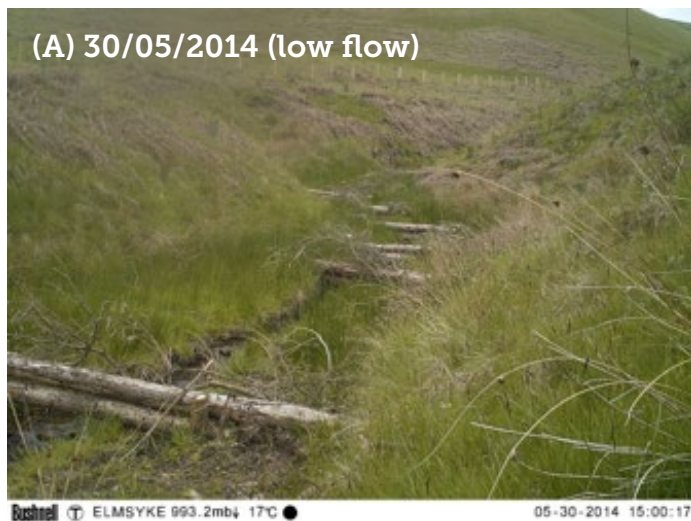
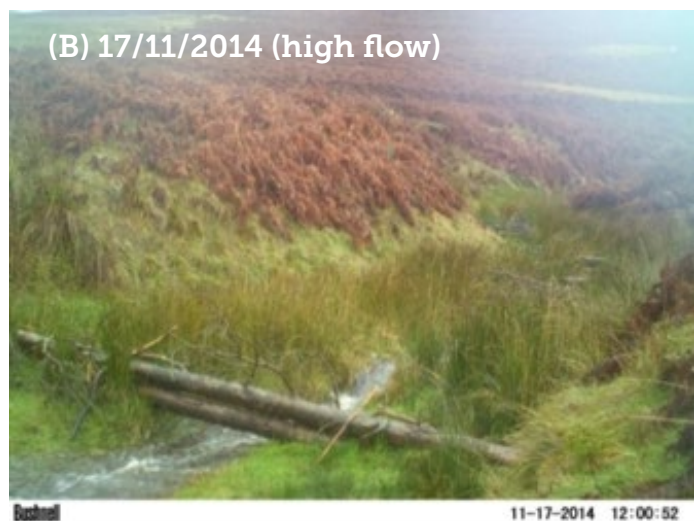
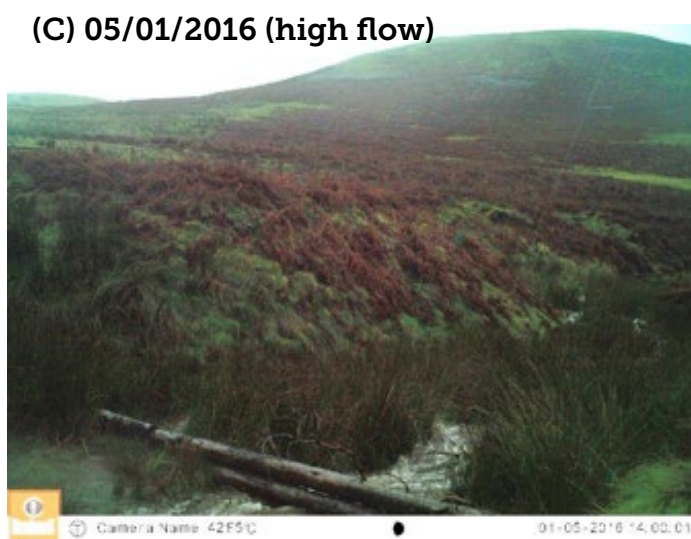
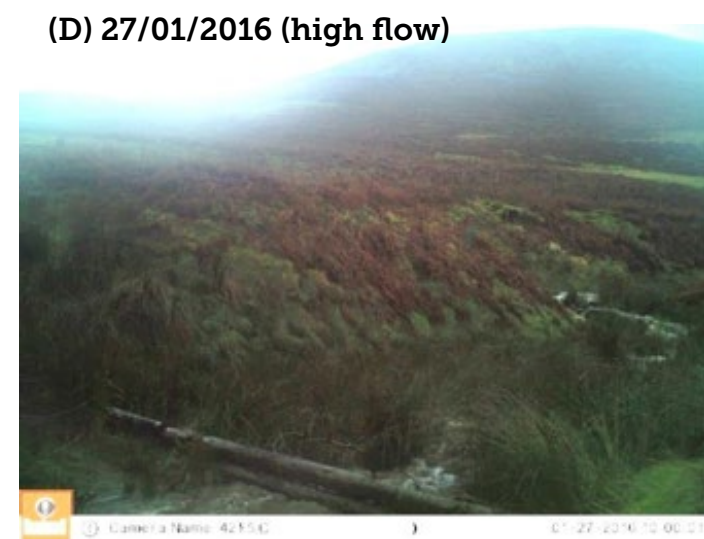
- Based on time lapse photography (Figure 37) and inference from geomorphic responses (Figure 38) and high flow trashlines, the hydraulic influence of most of the structures is likely to have been limited so far. This reflects their blockage of the channel cross section only during high flows (i.e. approximately bankfull or greater) which reduces the likelihood of backwater effects. It may also reflect the steep nature of the channel meaning that hydraulic interference is limited.

Figure 37: Selected time lapse photographs of structure S1 in the foreground with other lower structures visible in the background during different flow conditions.

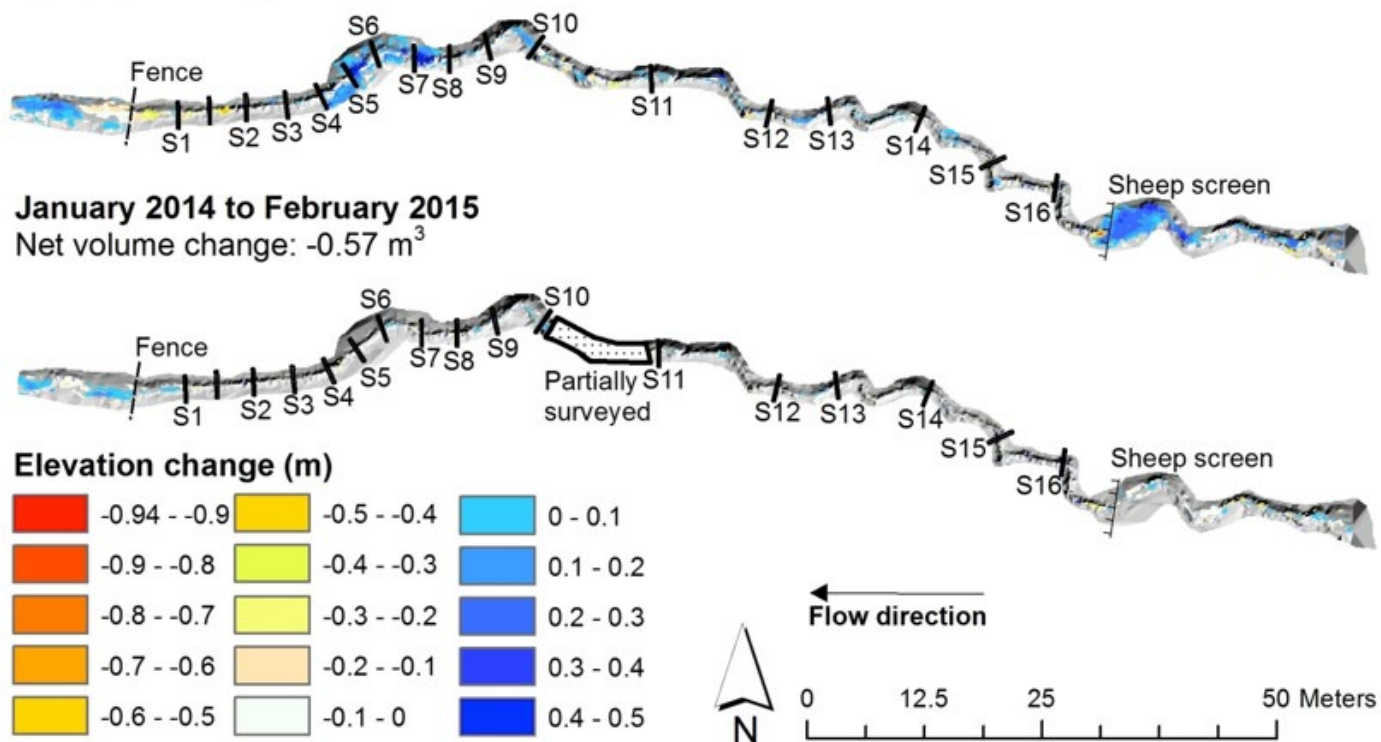
Figure 38: Distribution of elevation change during the two comparison periods between January 2014 and February 2016. Underlying hillshade topography maps dated to the first survey of each period are shown for context.
